# G1000 System Maintenance Manual Columbia 350/400

Figure 2-1. G1000/350/400 Display Configuration

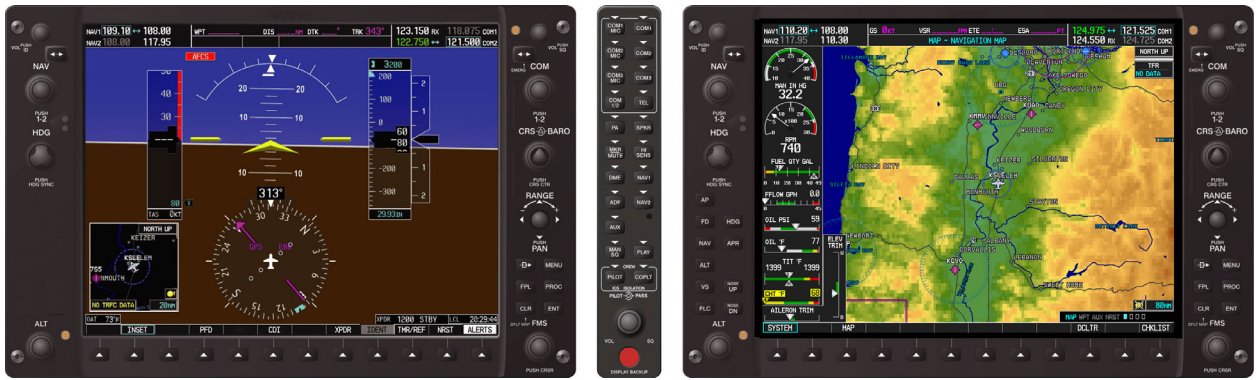
Two Garmin GDUs are installed in the 350/400 instrument panel. The PFD is a GDU 1040 and the MFD is a GDU 1042. Both displays provide control and display of nearly all functions of the G1000 integrated cockpit system. The displays are located side-by-side, with the GMA 1347 Audio Panel located in the middle.

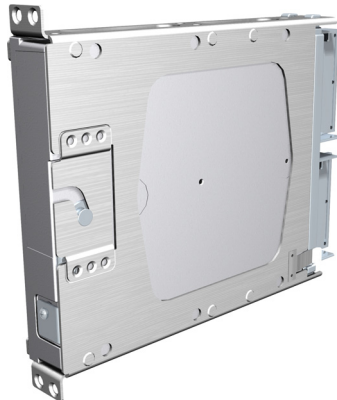
**Figure 2-3. GEA 71 Engine/Airframe Unit**

The Garmin GEA 71 Engine/Airframe Unit provides engine/airframe data to the G1000 system. Data received from transducers/sensors is processed, then sent via RS-485 to a GIA 63, and subsequently to the GDU 1040 MFD. The GEA 71 is connected to both GIA 63s for redundant communications. In display reversionary mode, engine instrumentation is displayed on the PFD as well. The GEA is located directly behind the PFD in its LRU rack. Power is received from the essential bus.

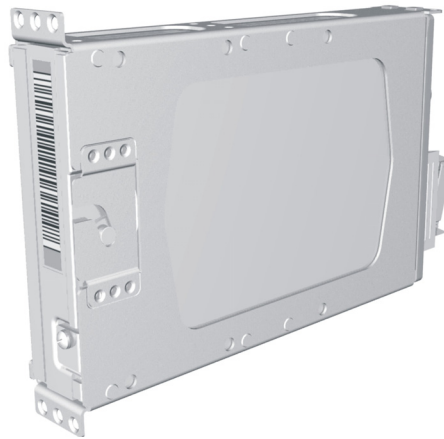
**Figure 2-4. GTX 33 Mode S Transponder**

The Garmin GTX 33 provides Mode A, C, and S altitude and position reporting information from the G1000 system. The unit is mounted directly behind the PFD in its LRU rack. Power is received from the Avionics Bus. The GTX 33 sends data via RS-232 directly to a GIA 63. Information is then sent to the PFD, where the pilot can control the transponder. The GTX 33 is connected to both GIA 63s for redundant communications. The GTX 33 interfaces with the existing transponder antenna.

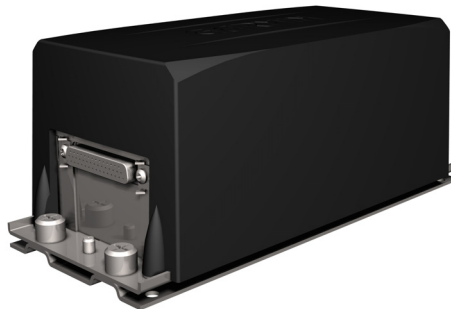
**Figure 2-6. GRS 77 AHRS**

The Garmin GRS 77 AHRS provides attitude and heading information to the G1000 system. The unit is mounted below the aft baggage compartment. Power is received from the Essential Bus. The GRS 77 interfaces with and provides power to the GMU 44 Magnetometer. The GRS 77 supplies attitude and heading information directly to the PFD, MFD, and to both GIAs.

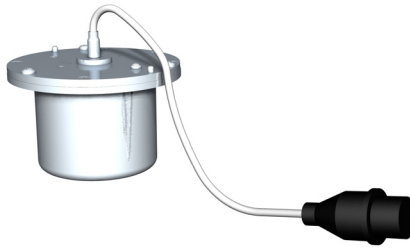
**Figure 2-7. GMU 44 Magnetometer**

The GMU 44 provides horizontal and vertical magnetic field information to the GRS 77 AHRS. This allows heading to be calculated and provides assistance during AHRS alignment. The GMU 44 is mounted at the left wingtip.

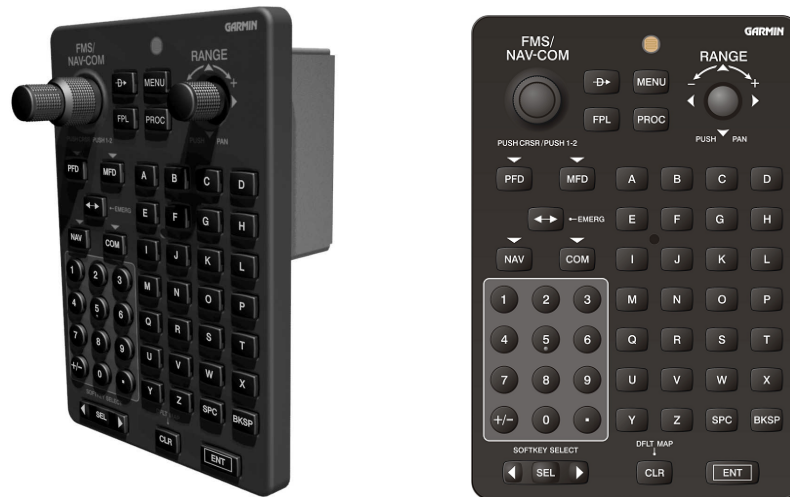
**Figure 2-10. GCU 476**

The GCU 476 interfaces with the GDU 104x PFD/MFD. The GCU 476 Remote Keypad provides alphanumeric, softkey, and flight planning function keys used to interface with the G1000. In addition to alphanumeric, softkey, and flight planning function keys the GCU 476 provides COM/NAV tuning capabilities. The GCU 476 mounts on the center console using a single jackscrew.

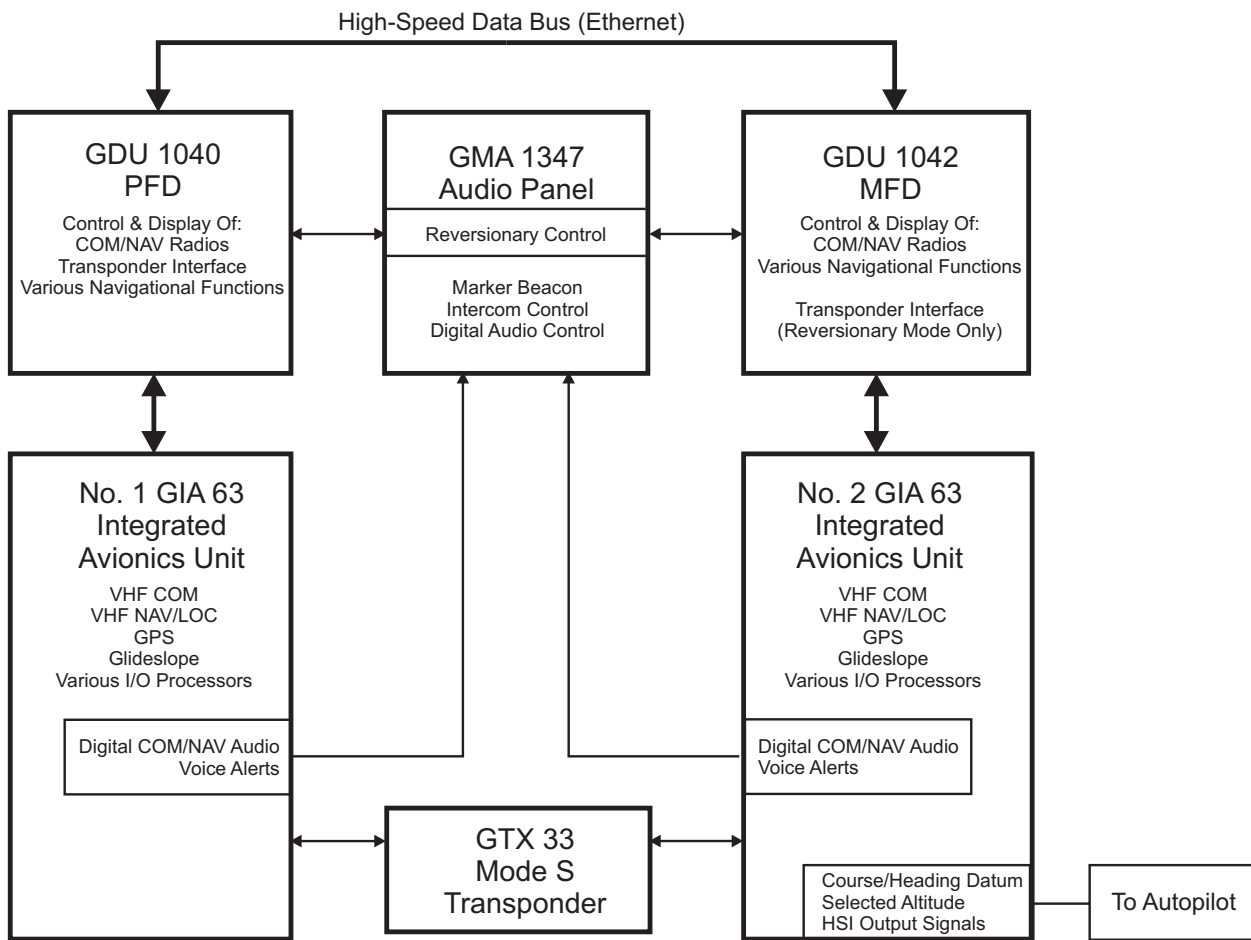
The GTX 33 Mode S Transponder communicates with both GIAs. Transponder data is sent from the GIAs to the PFD where control and operation occurs.

The GMA 1347 Audio Panel controls the display reversionary mode.

Figure 2-16. G1000 Navigation/Communications

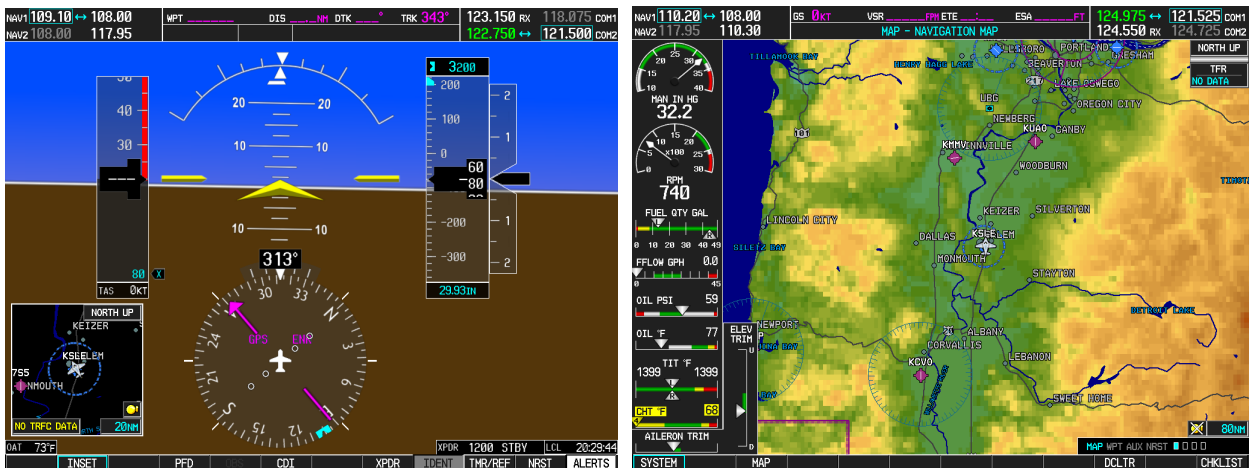
The G1000 system is now powered in the normal mode. The PFD and MFD will function as specified in the G1000 Cockpit Reference Guide for the Columbia 350/400 when the system has been correctly installed and configured.

Figure 3-6. Normal Mode

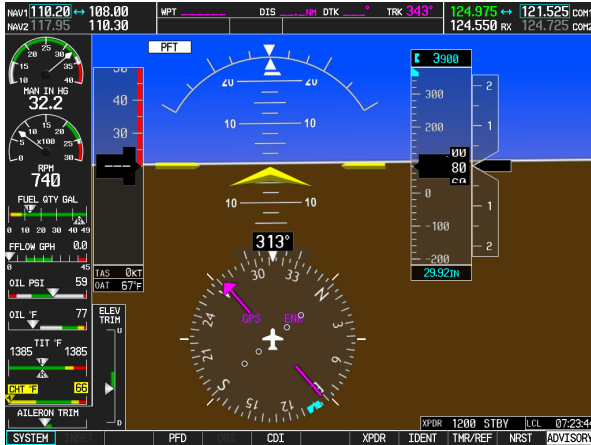
Should a display communication or hardware failure occur, the G1000 system automatically enters the reversionary mode. The system reversionary mode forces the remaining display into showing all information related to safe flight.

A manual reversionary mode also allows the operator to force the system into reversionary mode in situations where the system does not automatically enter reversionary mode. A large red button on the GMA 1347 audio panel activates the manual reversionary mode.

Figure 3-7. MFD Failure Mode

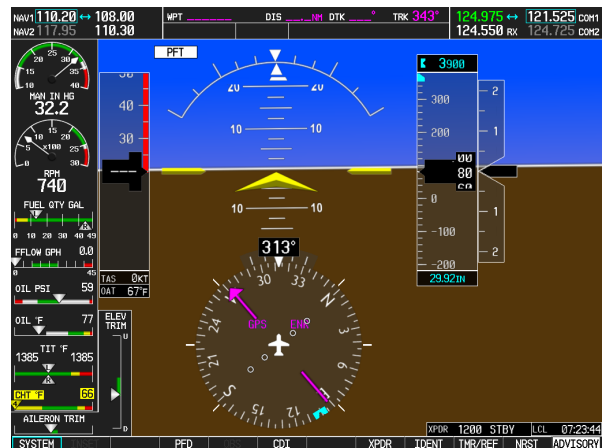
Should the PFD display fail, the MFD automatically enters reversionary mode. In this mode, flight-critical information from the AHRS/Air Data system is displayed on the MFD along with essential engine instrumentation.

Figure 3-8. PFD Failure Mode

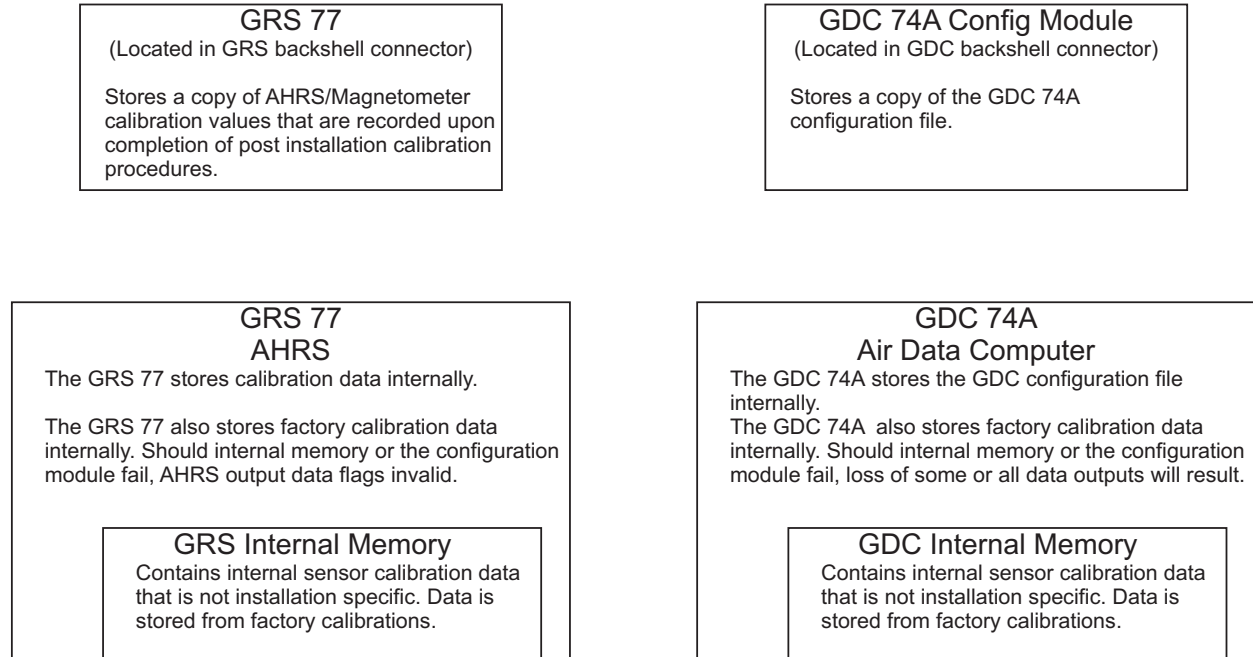
The GRS 77 and GDC 74A configuration modules function differently than the rest of the system. The GDC 74A's configuration file is loaded directly to GDC internal memory. A copy of the file is stored in the GDC configuration module.

The GRS 77 configuration module does not store any configuration settings. Rather, it stores calibration data recorded during installation calibration procedures.

**Figure 3-10. GRS/GDC Configuration Settings Storage**

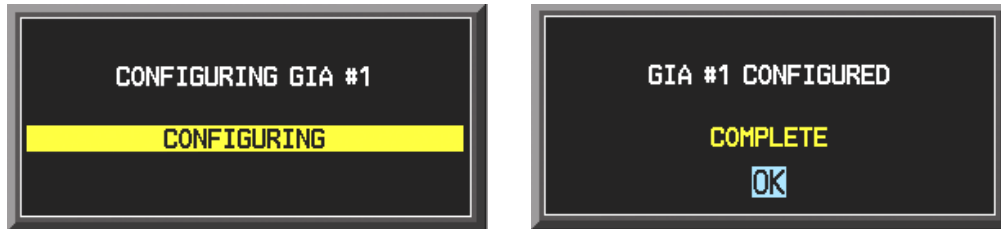
When configuration settings are changed, the technician receives on-screen prompts and/or confirmations such as those shown in Figure 3-13.

Figure 3-13. Configuration Status

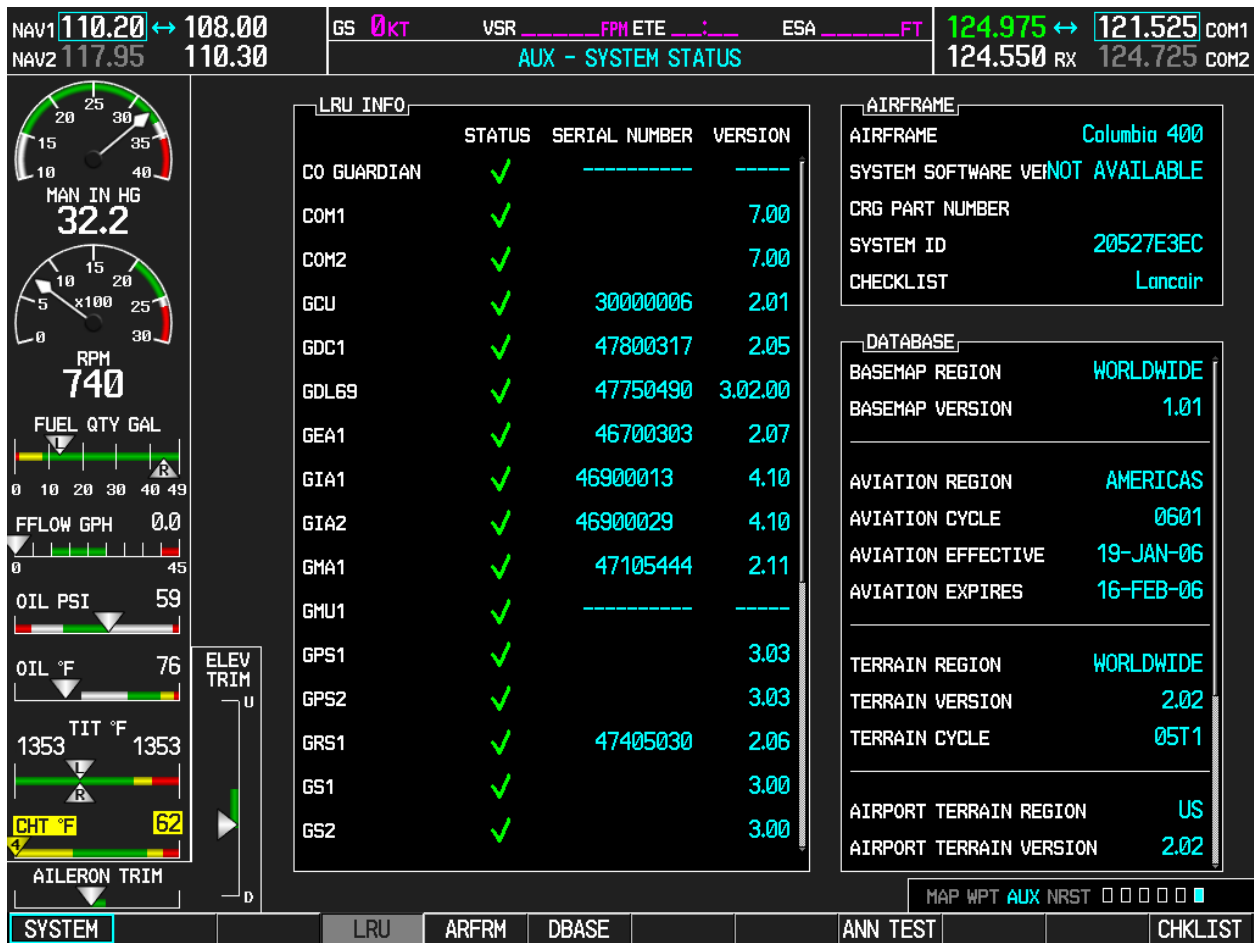
**Figure 4-1. System Status Page (AUX Group Normal Mode)**

The 6<sup>th</sup> AUX group page on the MFD provides LRU health status by means of a green check or a red 'X'. Also, LRU software versions are shown along with other database versions and dates. If a red 'X' is shown for an LRU, see the appropriate LRU troubleshooting section of this chapter for guidance. Typically, the G1000 Alerting System provides alerts/annunciations in conjunction with the information presented at the 6<sup>th</sup> AUX page.

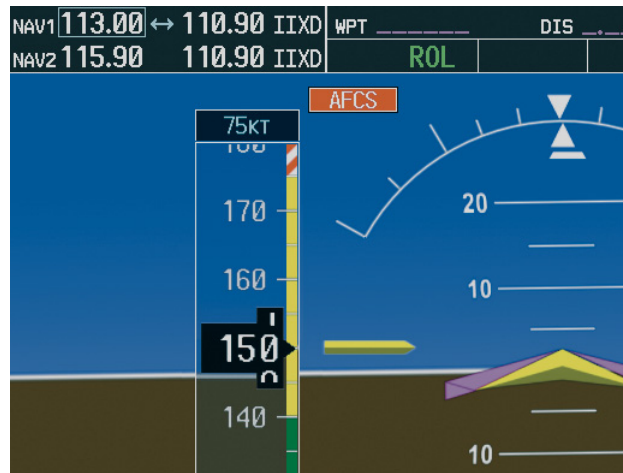
**Figure 4-7. AFCS Annunciation Field**

The GFC 700 AFCS Annunciation field is located above the airspeed tape on the PFD as shown:

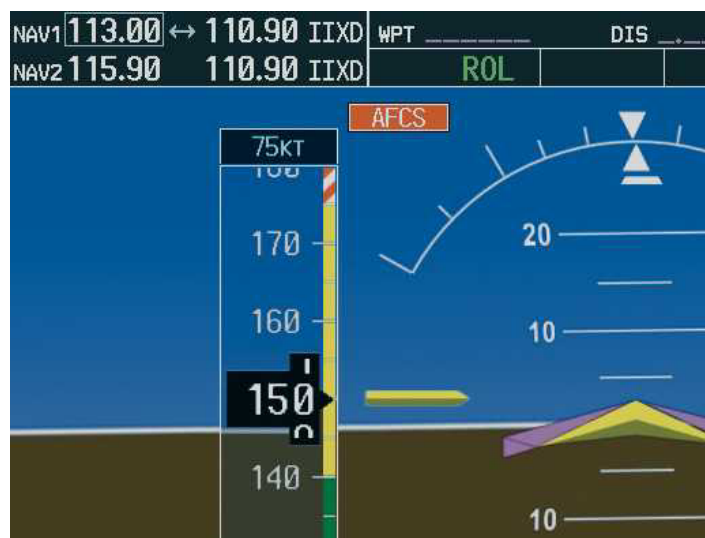
Figure 4-9. AFCS Annunciation Field

The GFC 700 AFCS Annunciation field is located above the airspeed tape on the PFD as shown in Figure 4-9.

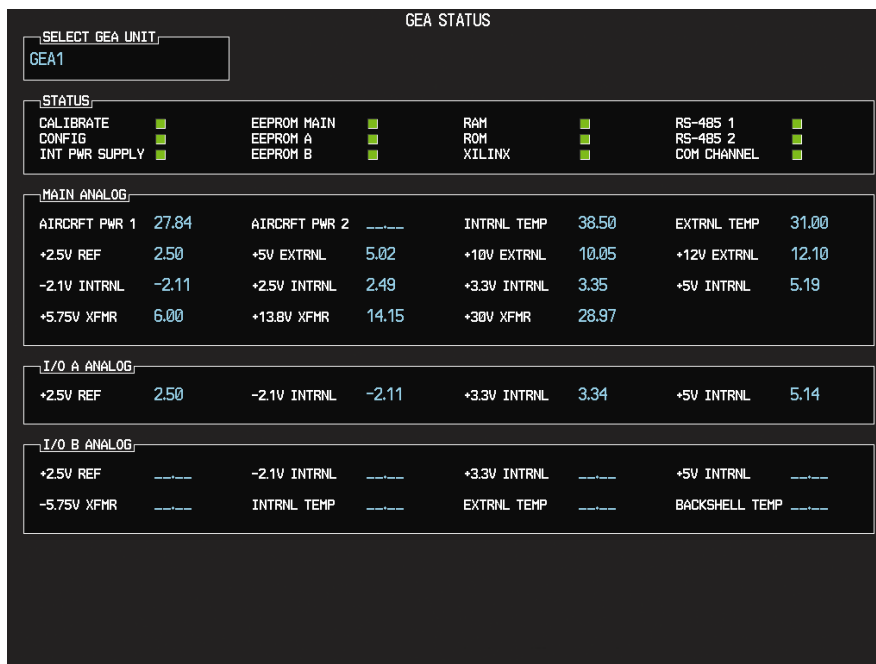
**Figure 4-18. GEA STATUS Page**

This page shows various items related to the GEA 71 and its operation. The technician can use this page to aid in diagnosis and troubleshooting of the GEA 71.

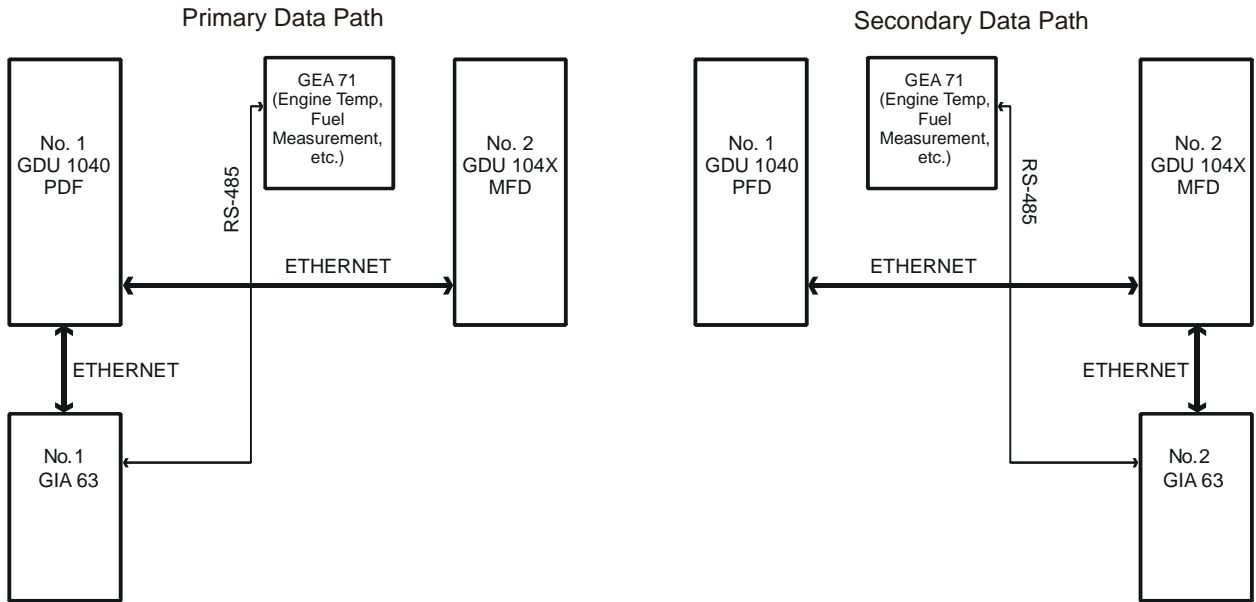
Figure 4-19. GEA 71 Data Paths

Message	Cause	Solutions
BACKUP PATH – EIS using backup data path.	The GEA 71 is using a backup RS-485 data path.	<ul style="list-style-type: none"> <li>See Section 4.7 for troubleshooting.</li> </ul>

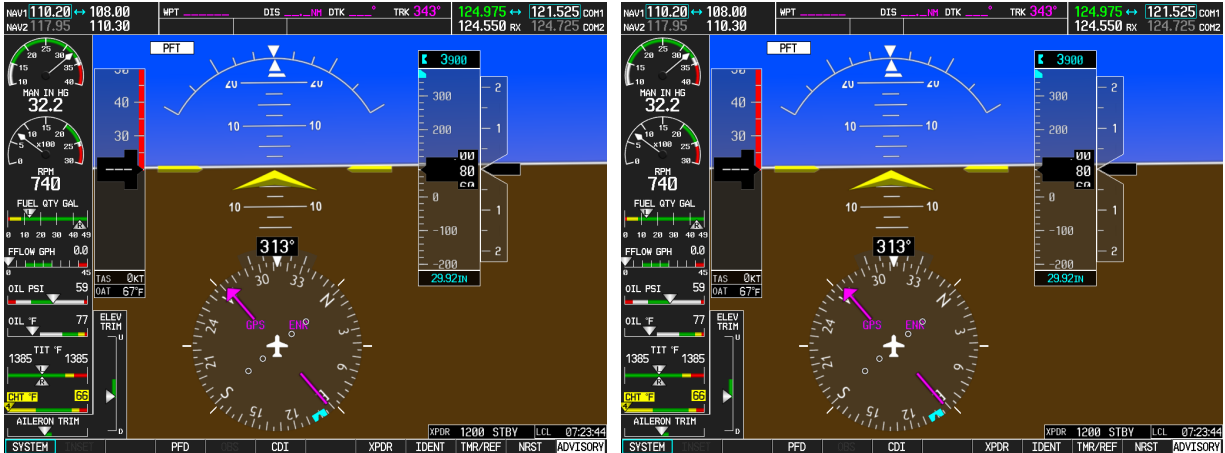
**Figure 6-2. G1000 Reversionary Mode Check**

3. Push the red display reversion button on the GMA 1347. Verify both displays enter reversionary mode (both should have valid attitude, heading, altitude, airspeed, vertical speed, and engine instruments):

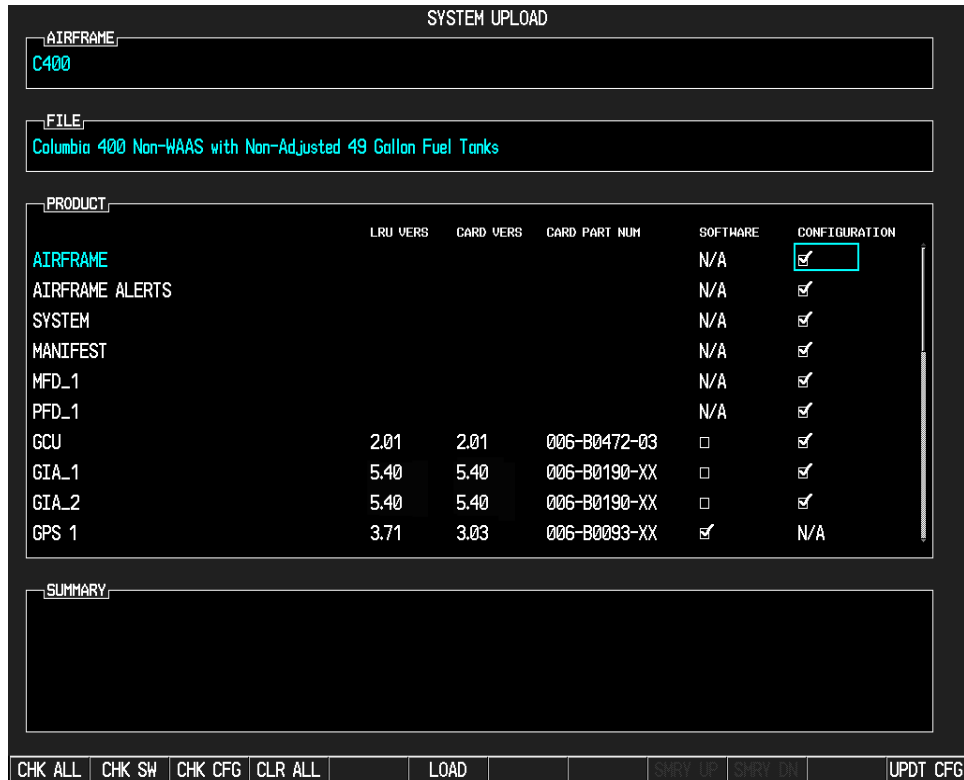
- The PRODUCT window will populate and display software and configuration file information for each G1000 LRU. The LRU VERS column shows the currently loaded software version in the LRU, whereas the CARD VERS column shows the LRU software version stored on the Loader Card. Each check designates a file to be loaded to the G1000.

By default, if an inequality between the LRU and CARD columns exists, the SOFTWARE CONFIGURATION boxes will be pre-selected (checked). By default all of the CONFIGURATION boxes will be pre-selected.

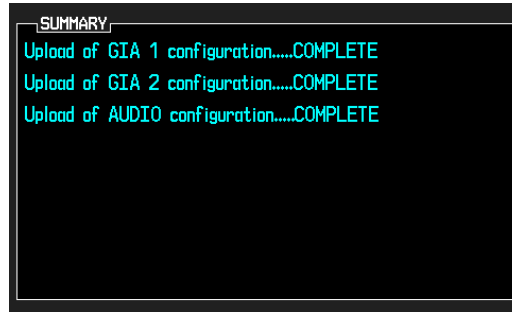
10. Highlight GIA2 in the FILE LIST field and repeat Steps 3 through 5.
11. Highlight AUDIO in the FILE LIST field and repeat Steps 3 through 5.
12. View the SUMMARY field and ensure that all items are 'COMPLETE':

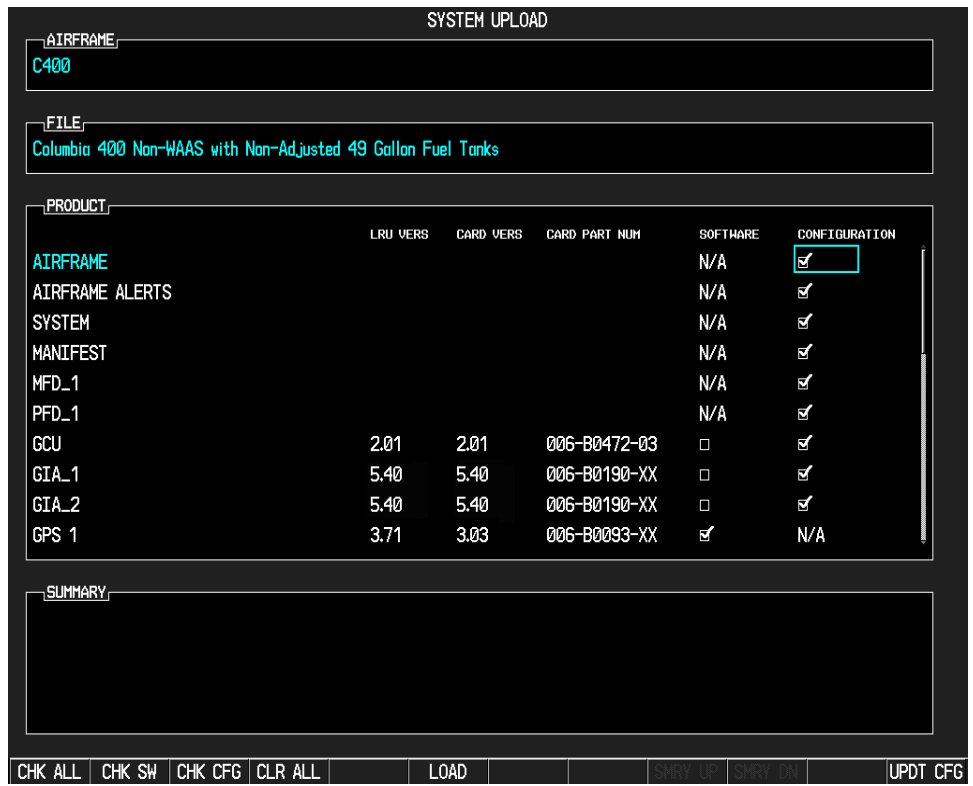
- The PRODUCT window will populate and display software and configuration file information for each G1000 LRU. The LRU VERS column shows the currently loaded software version in the LRU, whereas the CARD VERS column shows the LRU software version stored on the Loader Card. Each check designates a file to be loaded to the G1000.

By default, if an inequality between the LRU and CARD columns exists, the SOFTWARE and CONFIGURATION boxes will be pre-selected (checked).

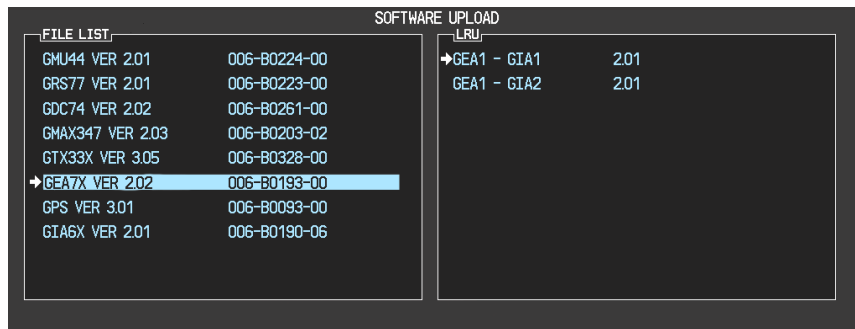
1. Remove the Supplemental Database cards from the bottom slots of each display. Note which card was removed from the MFD so it may be identified later for reinsertion in the MFD when software and configuration loading is complete. It contains a FliteChart or ChartView database which is only used by the MFD.
2. Insert the correct G1000-Columbia 350/400 Code Loader Card (see Required Equipment List) into the top slot of the PFD.
3. Start the G1000 system in Configuration mode.
4. On the PFD, go to the Software Upload page using the small FMS knob.
5. Highlight the GEA software file. Ensure that both paths to the GEA 71 through GIA1 and GIA 2 appear in the LRU field as shown:

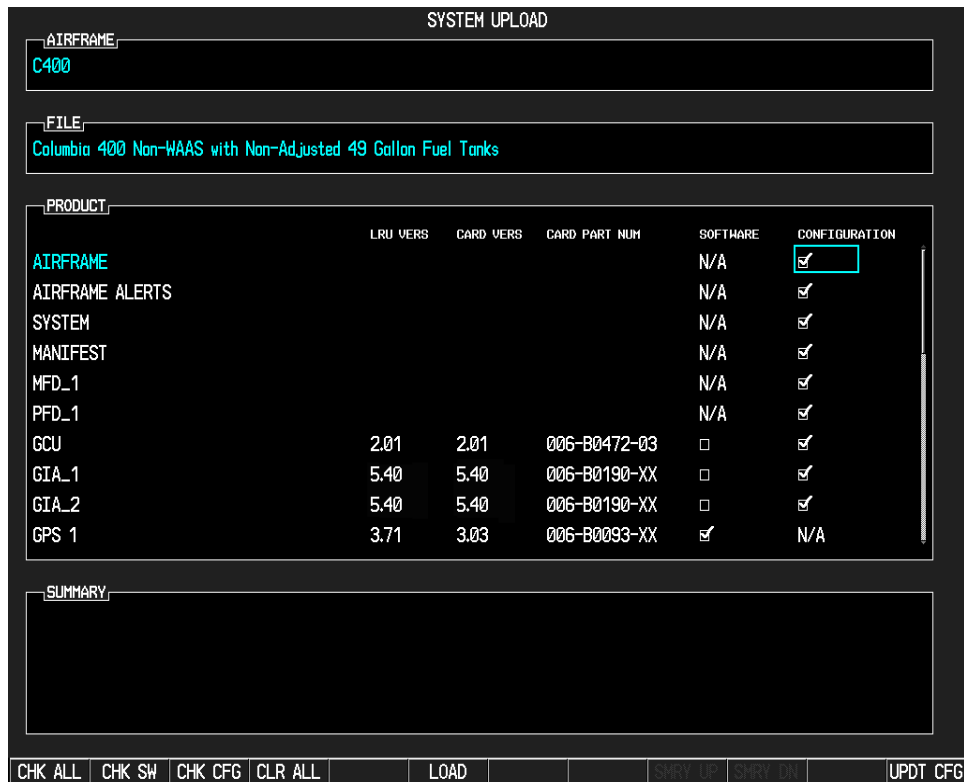
- The PRODUCT window will populate and display software and configuration file information for each G1000 LRU. The LRU VERS column shows the currently loaded software version in the LRU, whereas the CARD VERS column shows the LRU software version stored on the Loader Card. Each check designates a file to be loaded to the G1000.

By default, if an inequality between the LRU and CARD columns exists, the SOFTWARE CONFIGURATION boxes will be pre-selected (checked). By default all of the CONFIGURATION boxes will be pre-selected.

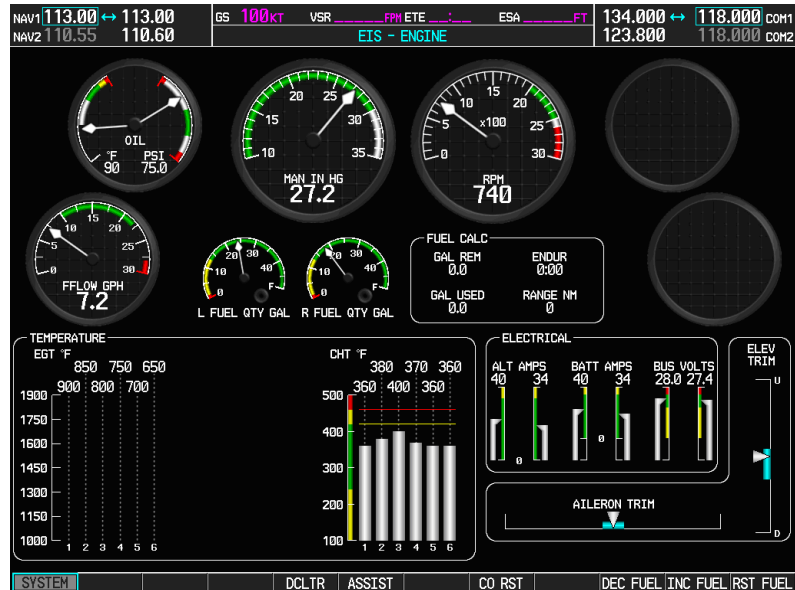
Figure 6-6. G1000/350/400 Engine/Airframe Indicators

Columbia 400 (with Oxygen System Option)

Columbia 350 (without Oxygen System Option)

On the MFD, check the indication for each of the sensor or monitor inputs with the aircraft engine off. Observe the 'Engine' page by using the SYSTEM softkey on the MFD. Observe the following sensor indications (see Figure 6-6):

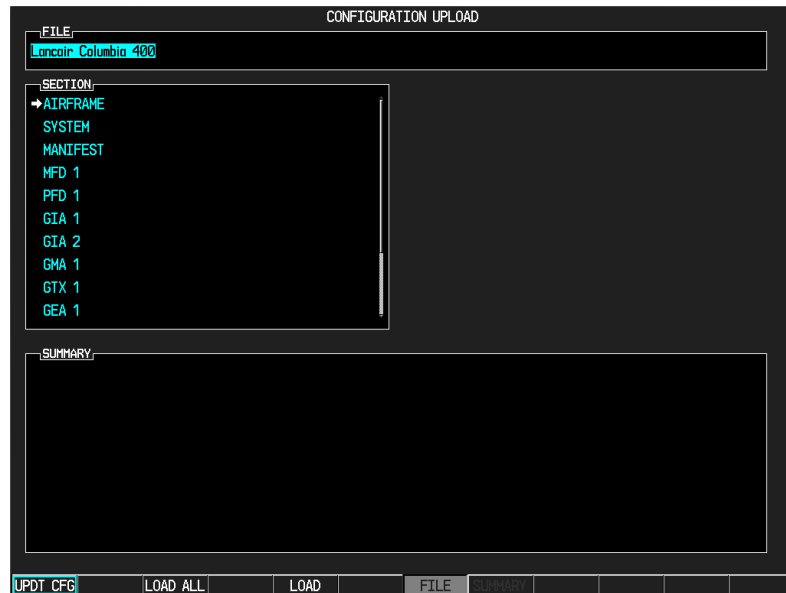
1. Insert the correct G1000-Columbia 350/400 Code Loader Card (see Required Equipment List) into the top slot of the PFD.
2. Start the G1000 system in Configuration mode.
3. On the PFD, go to the Configuration Upload page using the FMS knob:

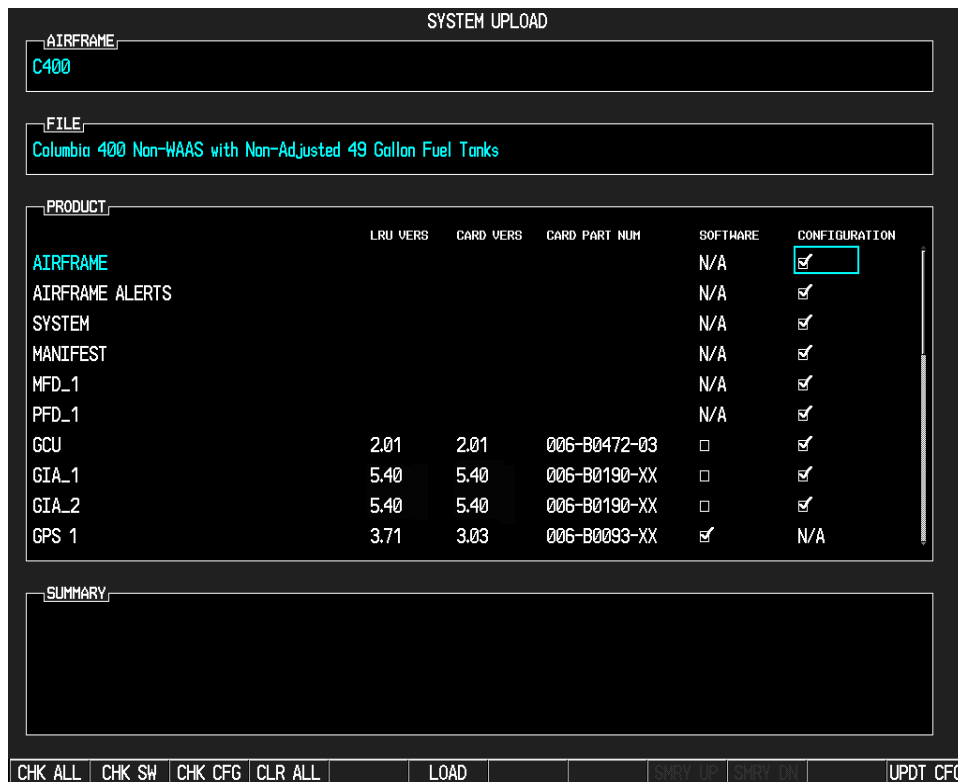
By default, if an inequality between the LRU and CARD columns exists, the SOFTWARE CONFIGURATION boxes will be pre-selected (checked). By default all of the CONFIGURATION boxes will be pre-selected.

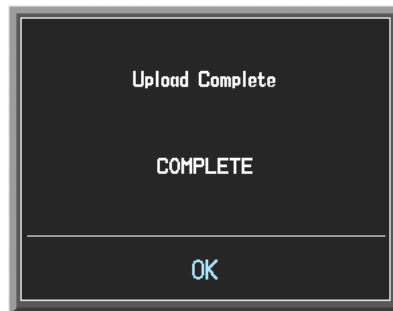
6. After verifying that the GTX software and configuration files are checked, press the LOAD softkey. It is acceptable to simply load the pre-selected software and config files. The G1000 system automatically begins loading software and default configuration files to the selected LRUs in the proper order.
7. When the system finishes loading, it prompts the technician accordingly. Press the ENT key to acknowledge that the upload is finished:

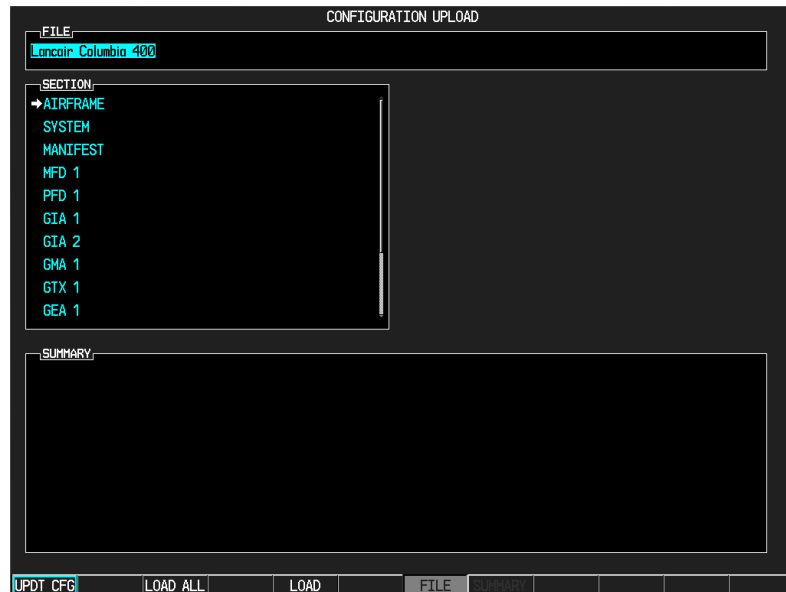
1. Insert the correct G1000-Columbia 350/400 Code Loader Card (see Required Equipment List) into the top slot of the PFD.
2. Start the G1000 system in Configuration mode.
3. On the PFD, go to the Configuration Upload page using the FMS knob:

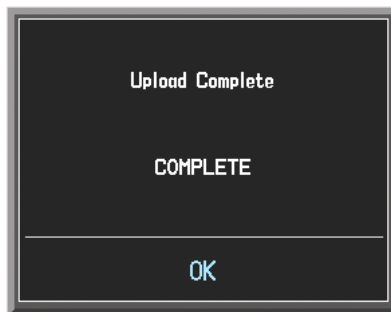
- After verifying that the GDC software and configuration files are checked, press the LOAD softkey. It is acceptable to simply load the pre-selected software and config files. The G1000 system automatically begins loading software and default configuration files to the selected LRUs in the proper order.
- When the system finishes loading, it prompts the technician accordingly. Press the ENT key to acknowledge that the upload is finished:

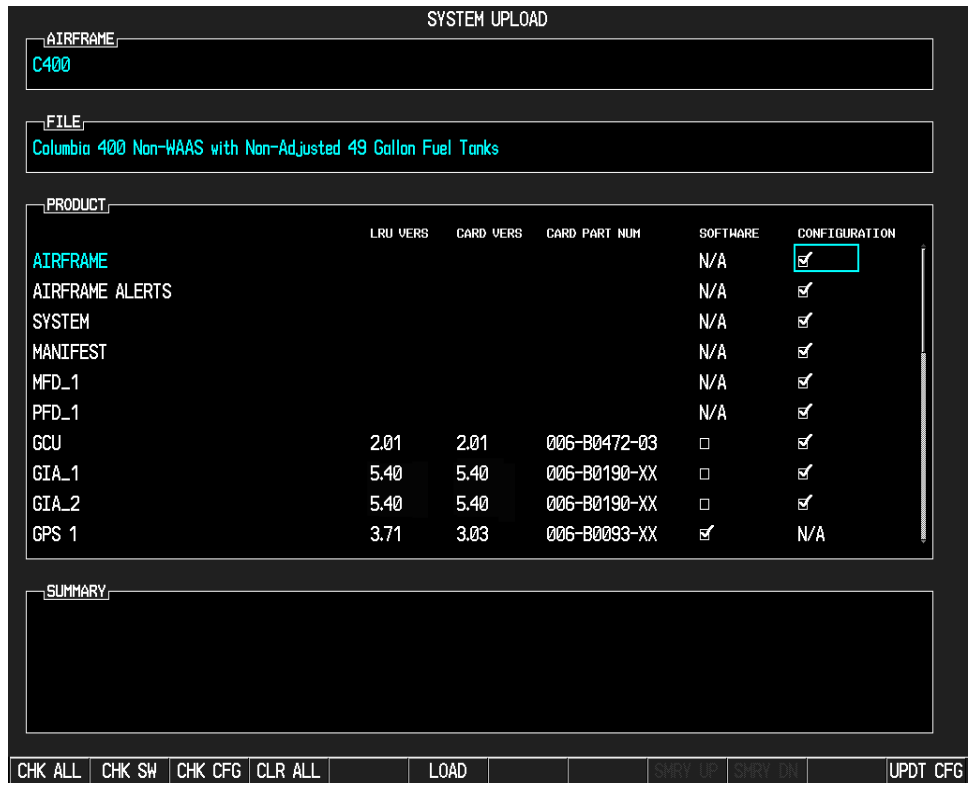
By default, if an inequality between the LRU and CARD columns exists, the SOFTWARE CONFIGURATION boxes will be pre-selected (checked). By default all of the CONFIGURATION boxes will be pre-selected.

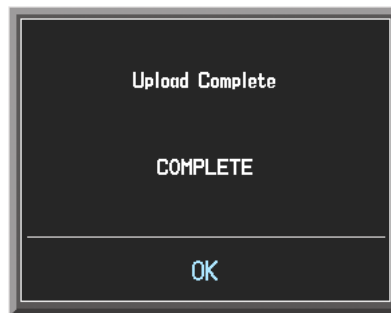
5. After verifying that the GRS/GMU software and configuration files are checked, press the LOAD softkey. It is acceptable to simply load the pre-selected software and config files. The G1000 system automatically begins loading software and default configuration files to the selected LRUs in the proper order.
6. When the system finishes loading, it prompts the technician accordingly. Press the ENT key to acknowledge that the upload is finished:

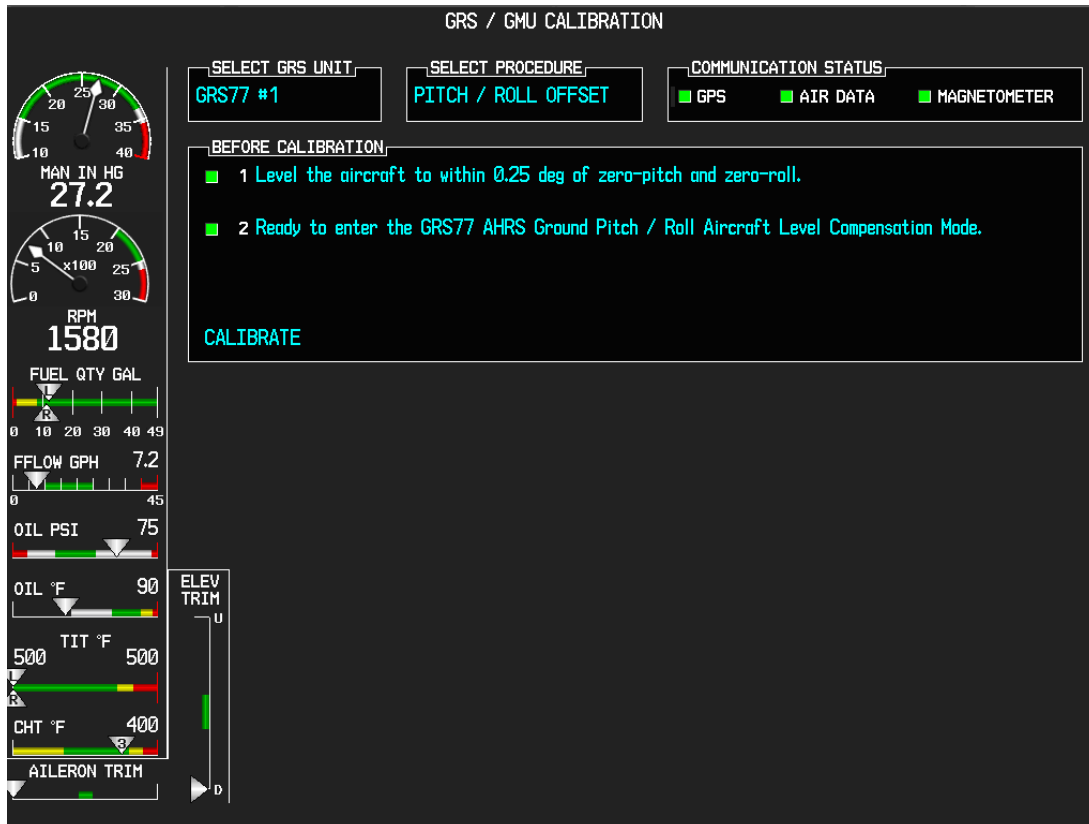
1. Level the aircraft to within  $\pm 0.25^\circ$  of zero pitch and zero roll using a digital level. (Follow instructions in the 350/400 AMM for leveling)
2. Start the G1000 system in Configuration mode.
3. On the PFD, go to the GRS Page Group and select the GRS/GMU Calibration page. This page is protected and the following softkey password must be entered on the PFD to continue:
  - a) 9
  - b) 10
  - c) 11
  - d) 12 (Far Right softkey)

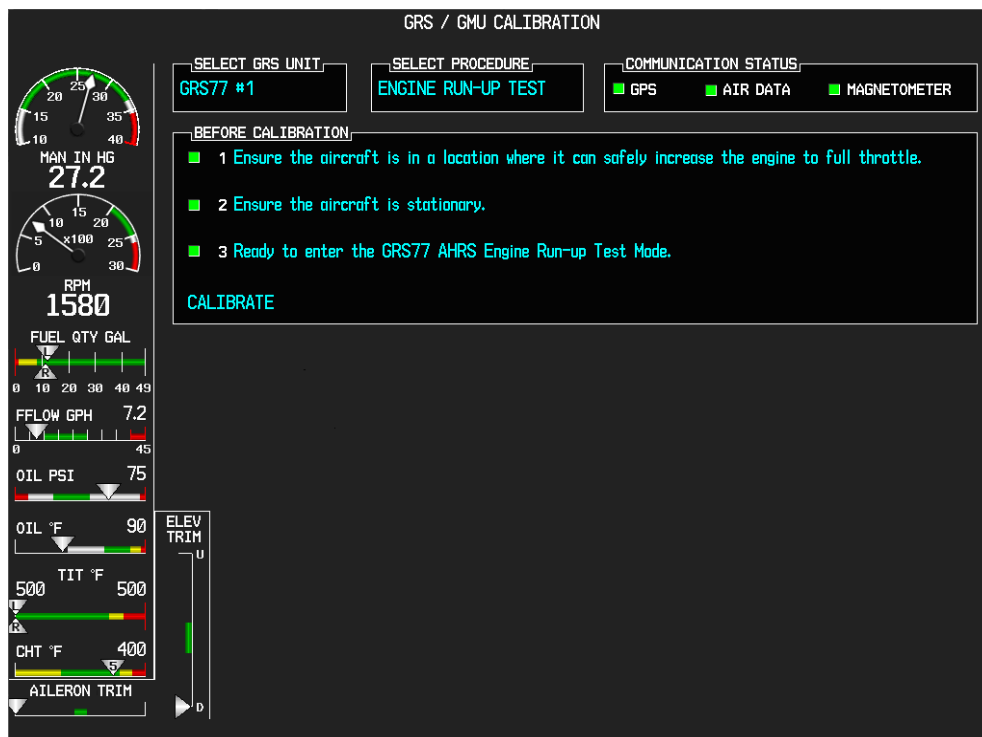
1. Start both displays in normal mode.
2. Start the aircraft engine following the procedures in the G1000/350/400 Airplane Flight Manual Supplement.
3. After aircraft engine startup, taxi the aircraft to a suitable area for engine run-up.
4. Restart both displays in configuration mode.
5. On the MFD, select the GEA page group. On the Engine Data page, monitor engine performance during the procedure.
6. Go to the GRS Page Group on the PFD.
7. Select the GRS/GMU Calibration page and enter the following softkey password:
  - a) 9
  - b) 10
  - c) 11
  - d) 12 (Far Right softkey)

8. Initiate the AHRS engine run-up vibration test procedure by performing the following steps:
  - a) Select the ENGINE RUN-UP TEST procedure and press the ENT key.
  - b) Follow the checklist items displayed on the PFD, and press the ENT key as each step is completed or confirmed.
  - c) When the CALIBRATE field is blinking, press the ENT key to begin the procedure.
9. The PFD instructs the operator to gradually increase power from idle to full throttle and back to idle over a period of 2-4 minutes.

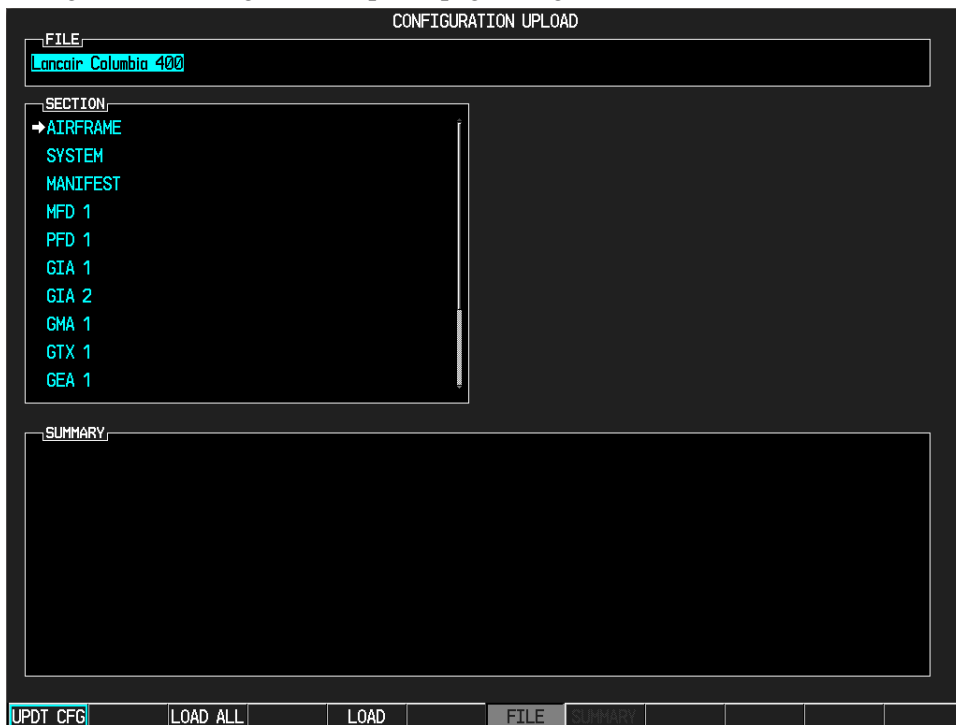
1. Insert the correct G1000-Columbia 350/400 Code Loader Card (see Required Equipment List) into the top slot of the PFD.
2. Start the G1000 system in Configuration mode.
3. On the PFD, go to the Configuration Upload page using the FMS knob:

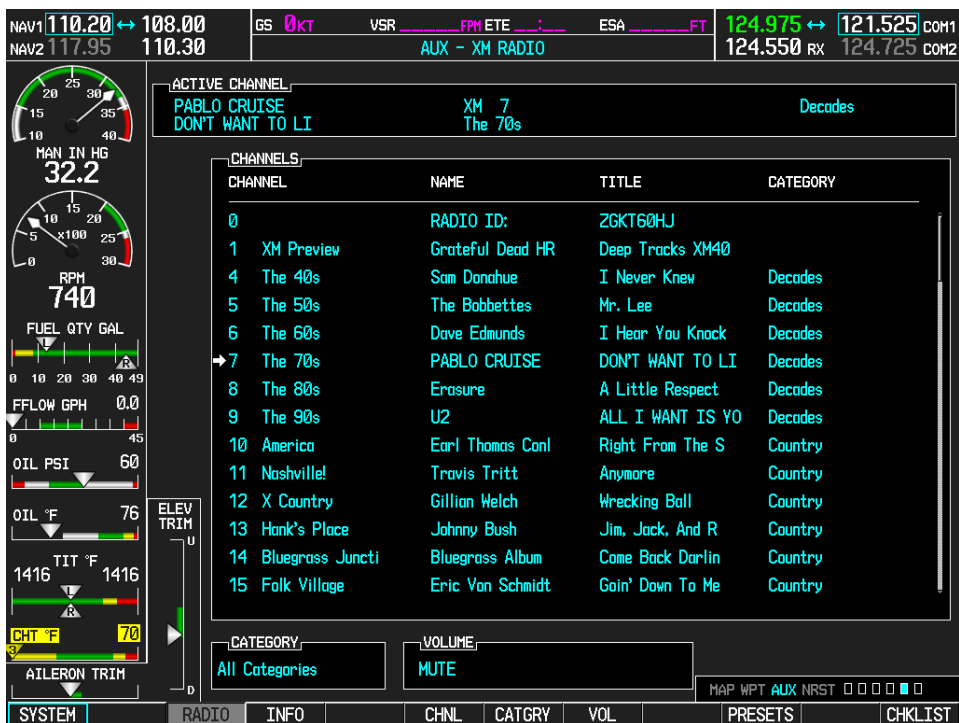
1. Select the AUX – XM RADIO page on the MFD.
2. Using the channel control located in the cabin, verify that you can increment and decrement the channels (the white arrow to the left of the channel list indicates the currently selected channel). Select channel 1 when complete.
3. Using the volume control located in the cabin, verify that you can increase and decrease the XM radio volume (the volume bar at the bottom of the screen will show changes to the volume level). Set the volume to the mid position when done.
4. Plug a set of headphones into one of the passenger stations and verify that you can hear the XM radio playing in both left and right channels. The volume level may be adjusted to a comfortable level at this point.
5. Plug a set of headphones into one of the pilot station and verify that you can hear the XM radio playing in both left and right channels.

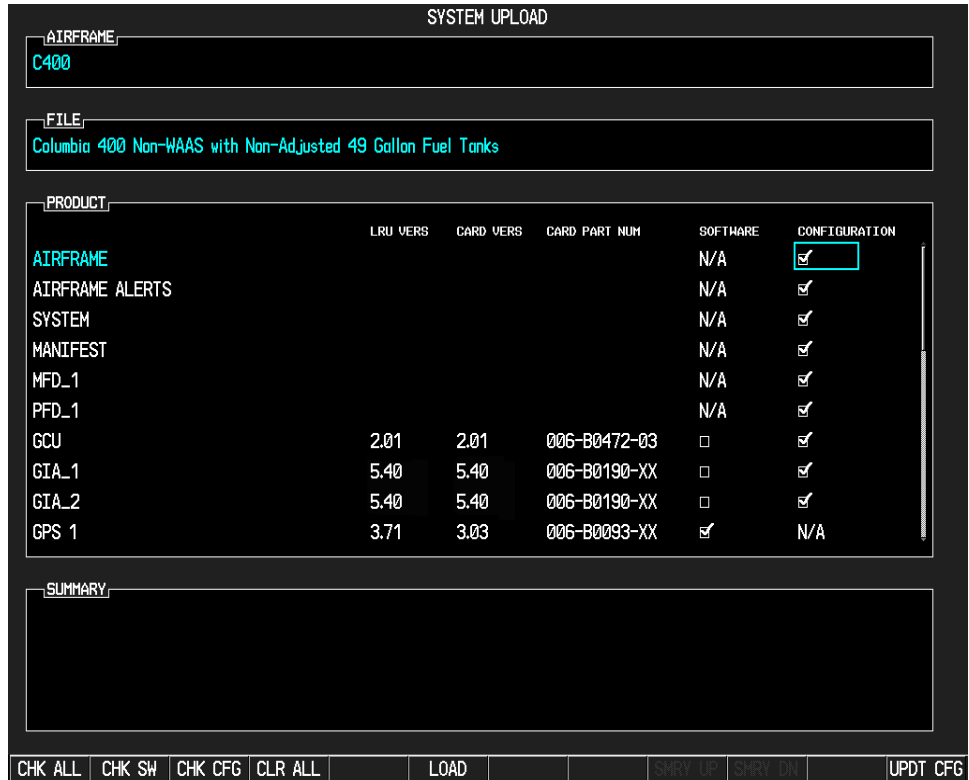
By default, if an inequality between the LRU and CARD columns exists, the SOFTWARE CONFIGURATION boxes will be pre-selected (checked). By default all of the CONFIGURATION boxes will be pre-selected.

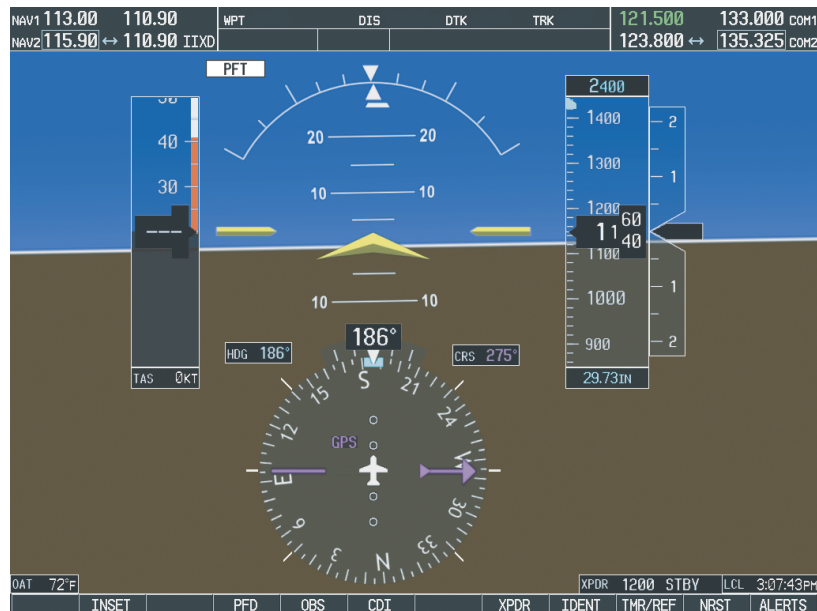
Figure 6-9. GFC 700 Pre-Flight Test

3. Verify that a white 'PFT' annunciation is displayed on the PFD, as shown in Figure 6-9.

4. Upon successful completion of the pre-flight test, an aural alert will sound and the 'PFT' annunciation will clear. Continue to Section 6.10.2.
