# G1000 System Maintenance Manual Columbia 350/400

Figure 2-1. G1000/350/400 Display Configuration

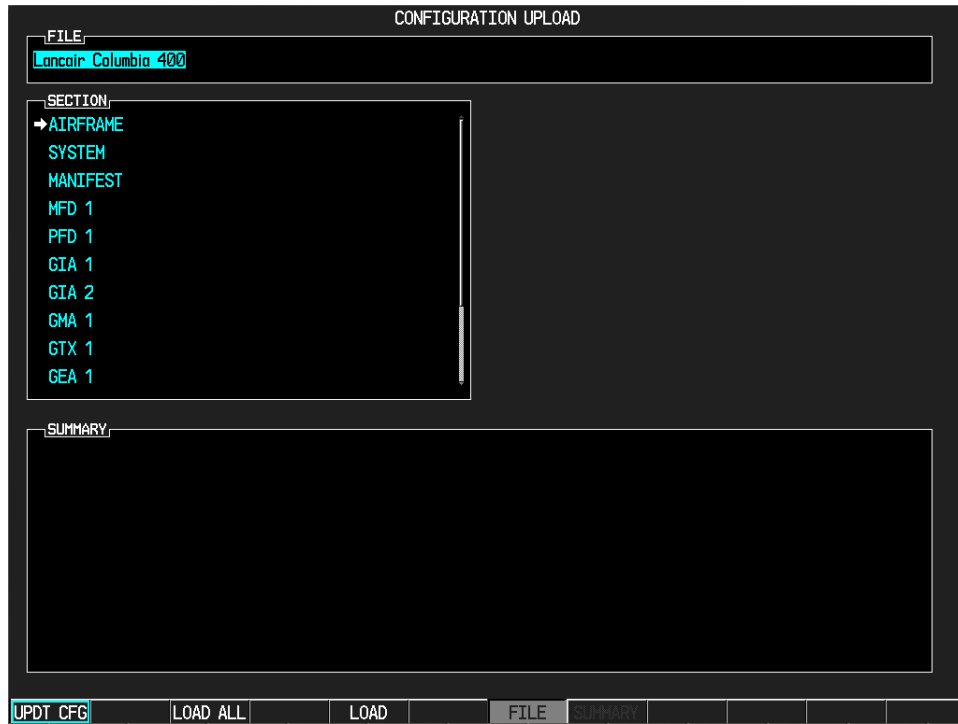
- Insert the correct G1000-Columbia 350/400 Code Loader Card (see Required Equipment List) into the top slot of the PFD.
- Start the G1000 system in Configuration mode.
- On the PFD, go to the Configuration Upload page using the FMS knob:

4. Activate the cursor and use the small FMS knob to highlight the airframe type in the FILE field.

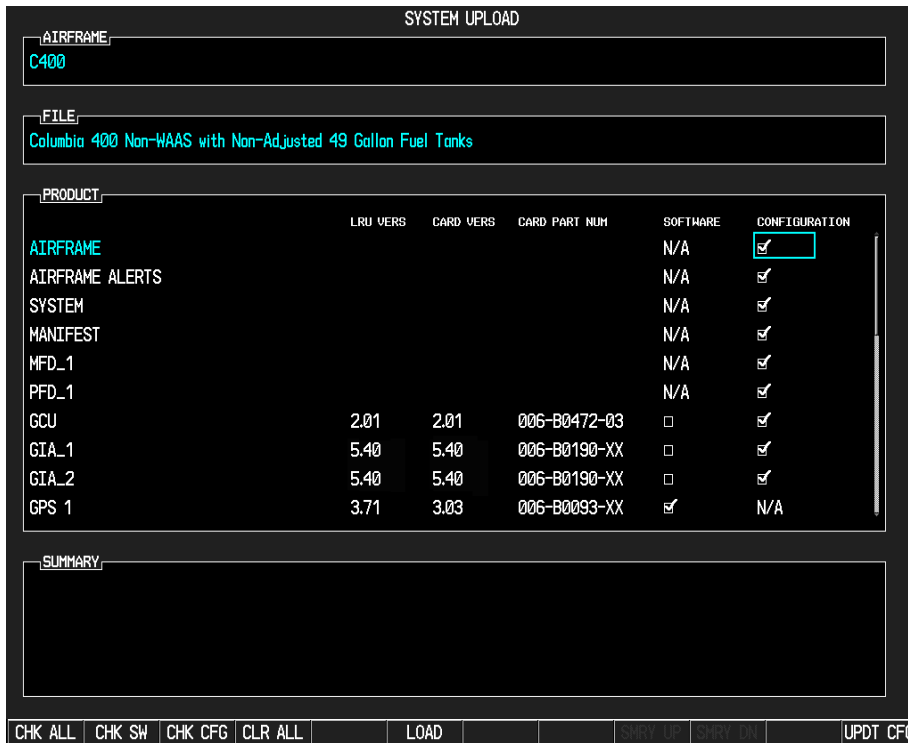
- The PRODUCT window will populate and display software and configuration file information for each G1000 LRU. The LRU VERS column shows the currently loaded software version in the LRU, whereas the CARD VERS column shows the LRU software version stored on the Loader Card. Each check designates a file to be loaded to the G1000.

By default, if an inequality between the LRU and CARD columns exists, the SOFTWARE CONFIGURATION boxes will be pre-selected (checked). By Default all of the CONFIGURATION boxes will be pre-selected.

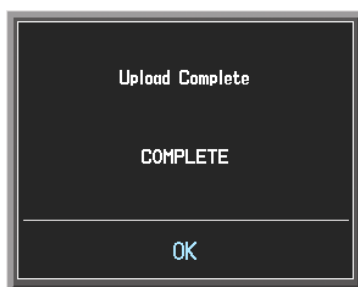
5. After verifying that the GCU keypad software and configuration files are checked, press the LOAD softkey. It is acceptable to simply load the pre-selected software and config files. The G1000 system automatically begins loading software and default configuration files to the selected LRUs in the proper order.
6. When the system finishes loading, it prompts the technician accordingly. Press the ENT key to acknowledge that the upload is finished:

7. Verify that each column indicates  PASS in green when the loading process has finished and inspect the SUMMARY window as well to ensure that the load is successful.
8. After the software and configuration files are loaded, turn off the system and reinsert the Supplemental Database Cards in the bottom slot of each display. Be sure to insert the card removed from the MFD back into the MFD.

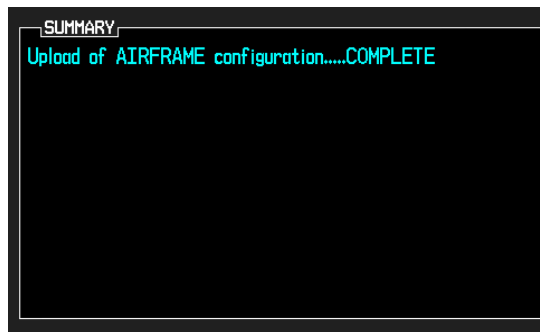
12. View the SUMMARY field and ensure that the item is 'COMPLETE':

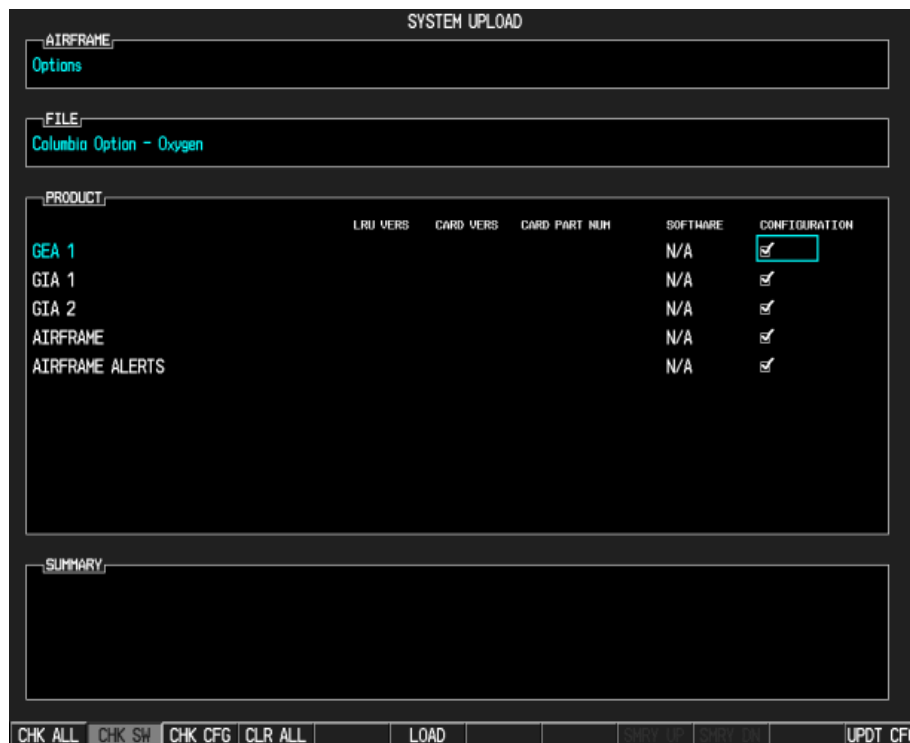
1. At the System Upload page, activate cursor and rotate the FMS knob once to activate the AIRFRAME menu.
2. Select 'Options' from the AIRFRAME window and press ENT.

- 
3. From the FILE window, select the 'Columbia Option – Oxygen' in the FILE field and press ENT
  4. Press the LOAD softkey.
  5. Monitor the status of the upload. When the upload is finished, press ENT to acknowledge.
  6. View the SUMMARY field and ensure that all items are 'complete': Verify that PASS appears in green at the check box(es) as shown:
