G1000 **NXi**

System Maintenance Manual

King Air 300 Series

**Includes Instructions for Continued Airworthiness
for STC SA01535WI-D**

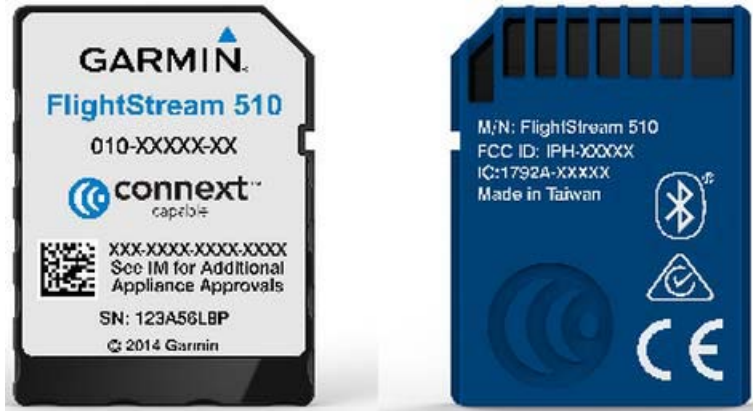
Figure 2-2, Flight Stream 510

The Flight Stream™ 510 (FS 510) is a Wi-Fi/Bluetooth capable multi-media card (MMC) installed the bottom SD slot of the MFD. It sends position, velocity, time, attitude, heading, FIS-B, TIS-B traffic, Sirius XM audio control, Sirius XM weather data, and flight plan transfer to mobile devices via Bluetooth. The FS 510 can also interface with a mobile device via Wi-Fi pairing for the purposes of updating databases used by the GDU(s). Bluetooth and Wi-Fi are mutually exclusive with only one interface functional at a time. Connecting via Wi-Fi requires a pilot-configurable Wi-Fi Protected Access WPA2 security password. By updating databases wirelessly, new databases may be transferred to the G1000 system without taking the data card out of the aircraft.

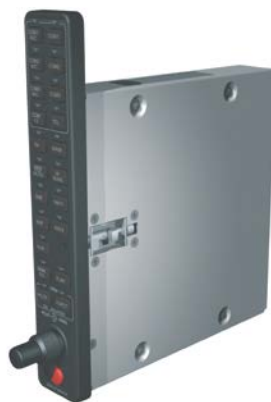
Figure 2-3, Audio Panel

The Garmin GMA 1347D Audio Panel integrates NAV/COM digital audio, intercom system and marker beacon controls. The 300 Series installation includes two GMA 1347D panels. The GMA 1347D panels provide control of all cockpit intercom/mic systems as well as NAV/COM/ILS audio. The units also provide display reversion mode control through a large red button. Warning and alert audio received by the GMA 1347Ds is processed by and received from the GIA 63W Integrated Avionics Units (IAUs). Electrical power to GMA 1 is provided from No. 1 Triple Fed Bus. Electrical power to GMA 2 is provided from No. 3 Triple Fed Bus. GMA 1 and GMA 2 will be powered immediately with external or aircraft power or battery operation. The GMA 1347D units interface with the existing marker beacon antenna, as well as existing mic and phone jacks and oxygen mask mic.

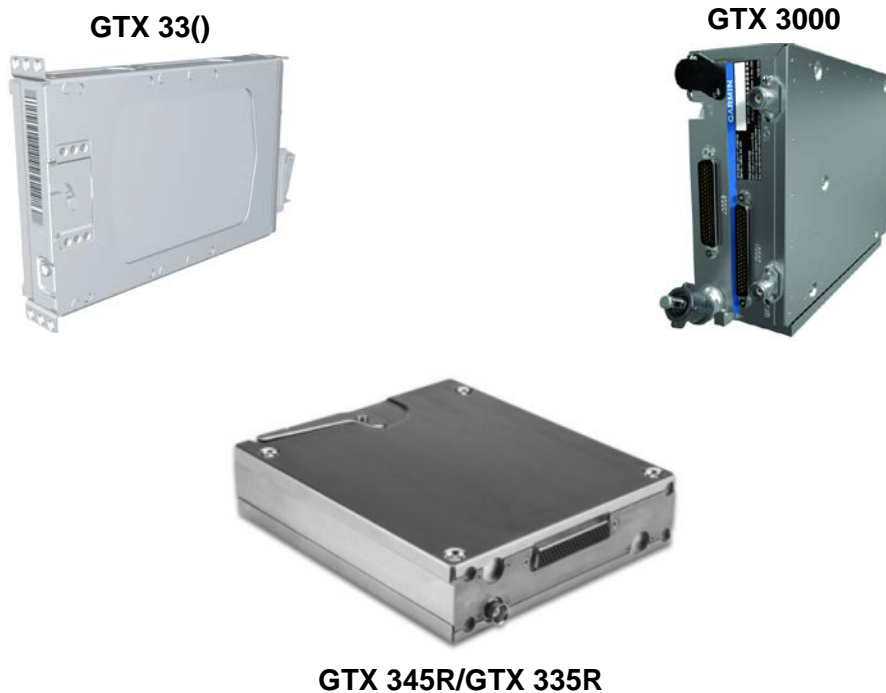
Figure 2-6, Transponders

For TCAS II operations, the GTX 3000 transponder communicates with the GTS Processor through ARINC 429 digital interfaces (transmit and receive). Only the GTX 3000 supports TCAS II operations with the GTS Processor.

The transponder units are mounted on the upper avionics equipment shelf in the tail section of the airplane. Power is provided by the No. 1 GTX from Triple Fed Avionics Bus. The No. 2 GTX is powered from Left Gen Avionics Bus. All GTX transponders (non-diversity and diversity) interface with a transponder antenna mounted to the bottom of the fuselage. Each GTX diversity transponder (GTX33D and GTX 3000) interfaces to a transponder antenna mounted to the top of the fuselage.

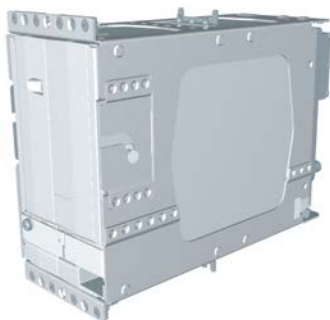
Figure 2-7, GIA unit

The GIA 63W #2 interfaces to the following additional equipment:

- GTX 33()#2, GTX 3000 #2, or GTX 335R#2
- ADF (if installed)
- Stormscope (if installed)
- Radar Altimeter (if installed)
- GDU 1050A #2

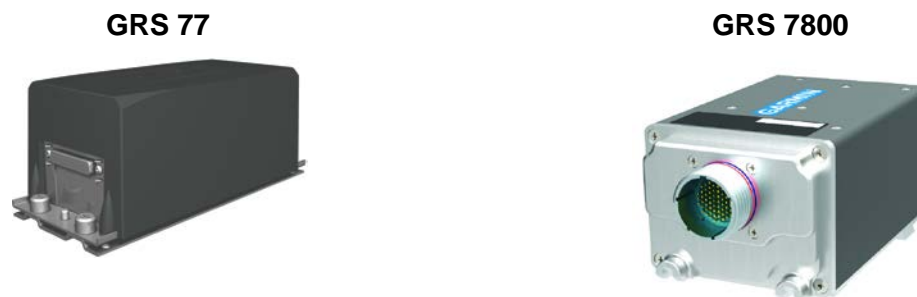
Figure 2-12, AHRS

Additionally, the GRS 7800 AHRS provides heading with or without the aiding of the Garmin GMU 44 magnetometer. When operating without the aid of the magnetometer, the GRS 7800 is functionally similar to that of a Directional Gyro.

GRS 1 receives primary electrical power from No. 1 Triple Fed Bus and a secondary power supply from the Center Bus. GRS 2 receives electrical power from No. 3 Triple Fed Bus.

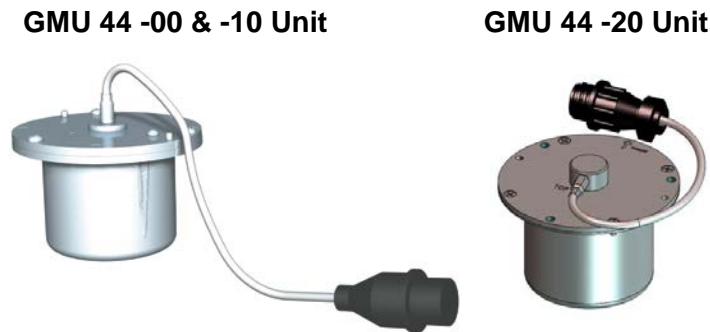
Figure 2-13, Magnetometer

The GMU 44 provides horizontal and vertical magnetic field information to the GSU or GRS. This allows heading to be calculated and provides assistance during ADAHRS/AHRS alignment. The GMU 44 units are mounted in the tailcone or in the horizontal stabilizer. The 011-00870-20 GMU 44 units may only be installed in the horizontal stabilizer. The GMU 44 units were modified to account for low clearance installations and have a 90-degree pig-tail harness versus the straight harness on the 011-08870-10 GMU 44 units. The units receive power directly from the GSU/GRS units and communicate with the GSU/GRS units via an RS-485 digital interface.

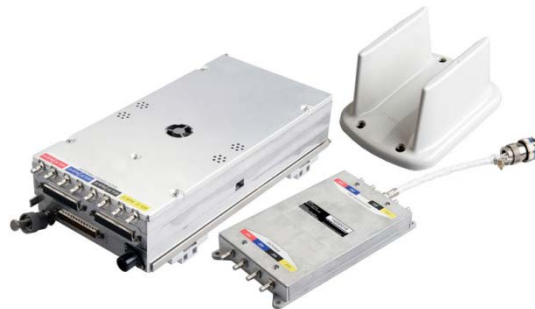
Figure 2-18, GTS 820/850 Traffic System

The GTS 820/850 is a traffic surveillance system that uses active interrogation of Mode S and Mode C transponders to provide traffic advisories to the pilot. The GTS 820 is a TAS unit; the GTS 850 is a TCAS I unit. The installation includes a top directional antenna (GA 58) paired with a GPA 65 power amplifier / low noise amplifier (PA/LNA) unit and a bottom, unamplified GA 58 antenna. The GTS 820/850 is located in the nose avionics bay on the top, left shelf. The GPA 65 is located in the left sidewall area, just in front of the most forward cabin window. The GTS 820/850 traffic system is powered from the Right Gen Avionics bus.

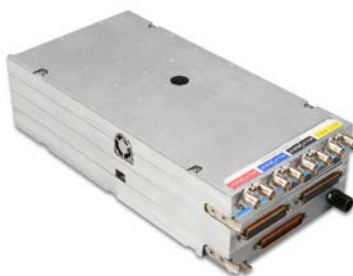
Figure 2-19, GTS Traffic Processor

The GTS Traffic Processor is a microprocessor-based Line Replaceable Unit that uses active interrogations of Mode S and Mode A/C transponders to provide Traffic Advisories and Resolution Advisories (GTS 8000 only) to the pilot. When installed, the GTS Processor can be configured as TAS (GTS 825), TCAS I (GTS 855), or TCAS II (GTS 8000). The GTS traffic processor is installed in the nose avionics bay. The GTS interfaces to the GA 58 traffic antennas which are mounted on the upper and lower fuselage. The GTS traffic processor also interfaces with the GTX 3000 (when installed) through ARINC 429 digital data lines. When a GTX 345R is installed, The GTX communicates with the GTS processor via the G1000 HSBD bus. The GTS traffic processor is powered from the Right Gen Avionics Bus.

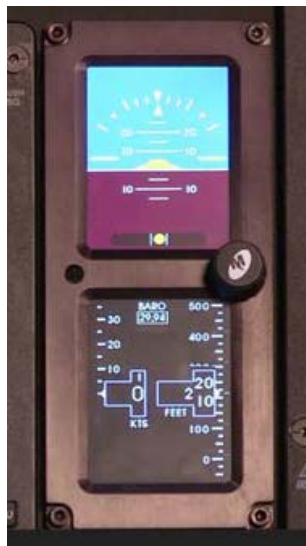
Figure 2-24, MD 302 Standby Attitude Module

Mid-Continent Instruments, part number 6420302-2, is an electronic 3-in-1 standby indicator assembly instrument with two 2.4" diagonal LCD displays provides standby altitude, airspeed, and attitude information to the cockpit. It is powered from Standby Instrument Bus and the emergency standby battery. Lighting Control is connected to the No.1 Dual Fed Bus. It receives static and pitot pressures from the right-hand pitot/static system. The MD 302 is a standalone unit and does not interface to any G1000 avionics. The MD302 is installed on the main instrument panel, between the pilot's PFD and the MFD.

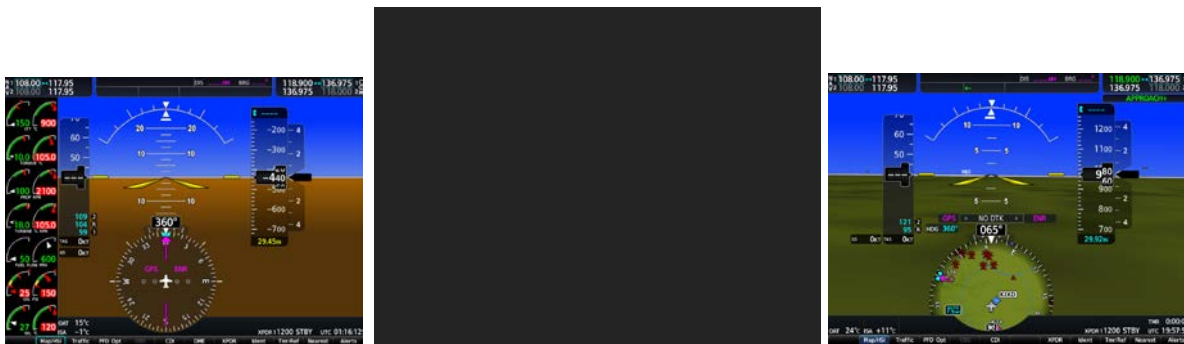
Figure 2-38, Automatic Reversion with MFD failure

Reversionary mode allows for display of information related to safe flight in the event of a display communication or hardware failure. The pilot's PFD automatically goes into reversionary mode when communication to the MFD is lost. Manual reversionary mode allows the operator to force the pilot or copilot's PFD into reversionary mode by pressing the large red button labeled 'DISPLAY BACKUP' on the respective GMA 1347D audio panel.

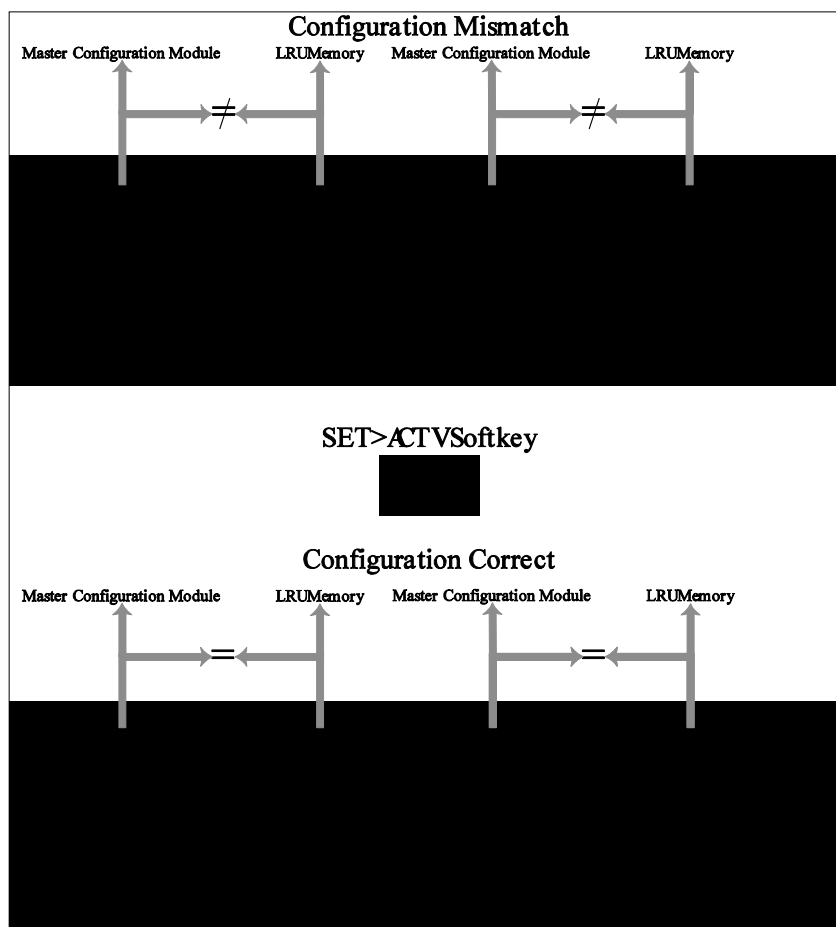
Figure 3-1, SET>ACTV Diagram

In the first example shown in Figure 3-1 the SET columns do not match the ACTIVE columns. The inequality between SET and ACTIVE indicates a configuration mismatch. By pressing the SET>ACTV softkey, this copies the SET column to the LRU unit's configuration memory. The settings then become the ACTIVE settings for the LRU being configured.

When troubleshooting the system, technicians can look for inequalities between SET and ACTIVE columns. Certain problems can be resolved simply by pressing the SET>ACTV softkey, which reloads settings to the specific LRU from the PFD. (Note that this can also be accomplished by reloading the configuration files for the LRU. Section 7 describes this process for each LRU).

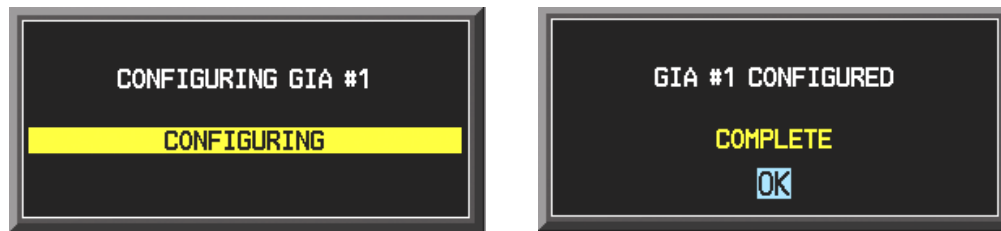
Figure 3-3, Configuration Status

When configuration settings are changed, the technician receives on-screen prompts and/or confirmations such as those shown in Figure 3-3.

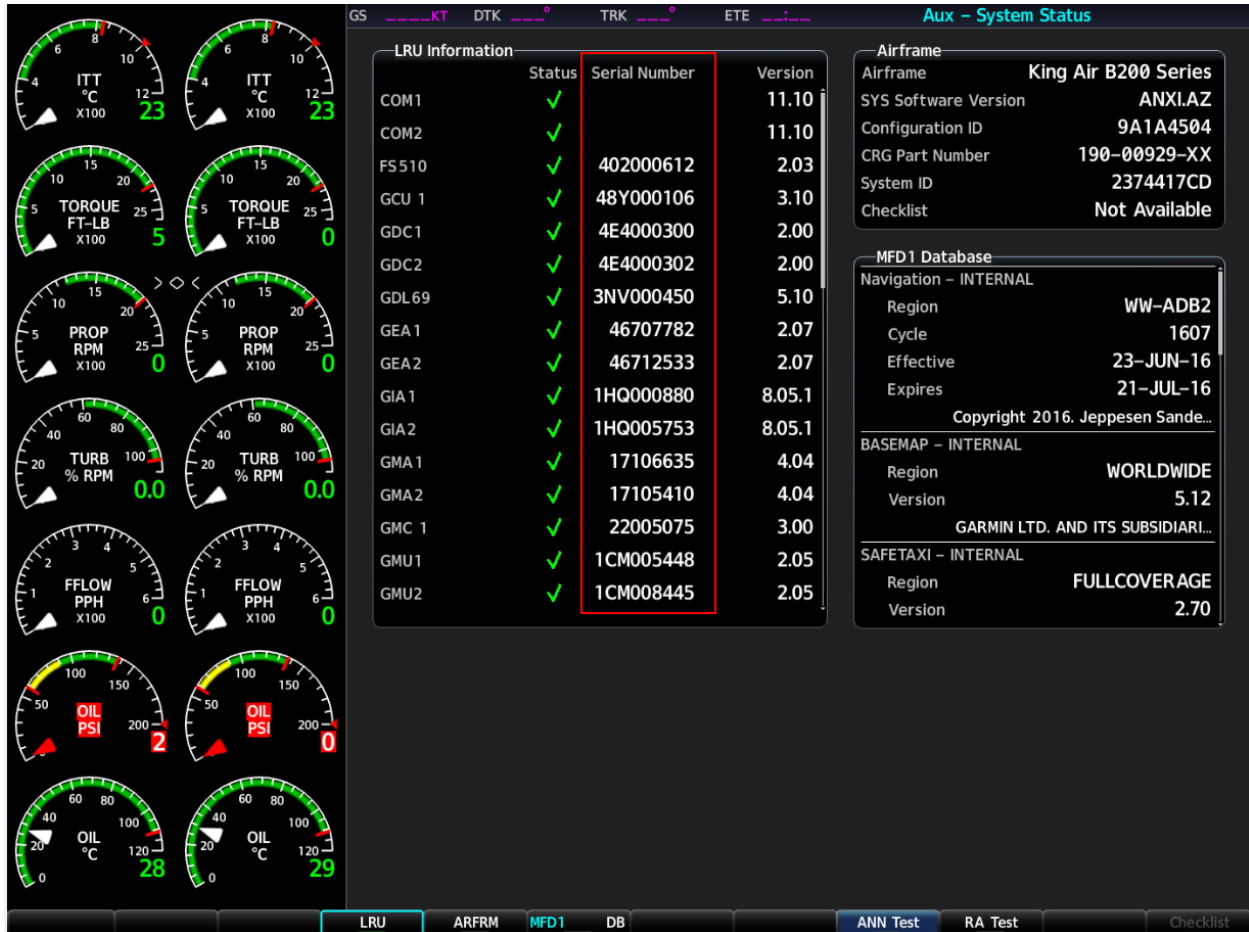
Figure 3-7, Garmin Unit S/N Location

Use the table in Appendix A to determine what the unit part number is based on the unit's serial number reported on the MFD Aux - System Status page in Normal mode or PFD1 System Status page in Config mode. This table lists the units that have different loader card option files so the installer can choose the correct file without requiring the unit to be physically inspected.

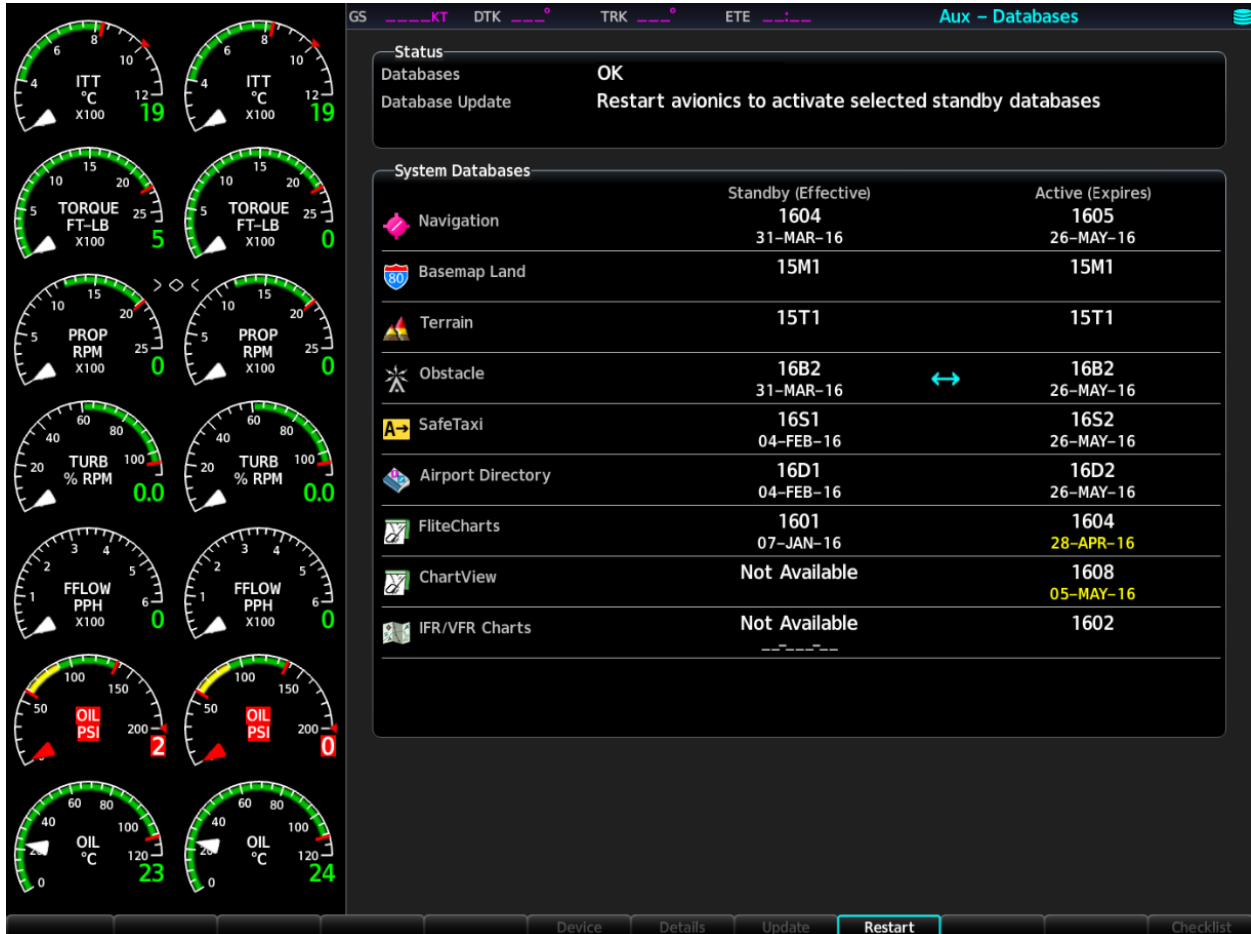
Figure 3-12, MFD Aux - Database Page DB Transfer

4. On the MFD, database verification messages may appear. If so, follow the on-screen instructions to continue.
5. Go to the MFD Aux - Databases page to monitor the automatic database update progress. The new databases will show “Syncing” to the Standby column. After the databases are synchronized, the system will verify them for use by showing “Verifying” in the Standby column. After the databases are verified, a cyan double arrow symbol will appear between the Standby and Active columns to show which databases will be transferred to Active use on the next power cycle.

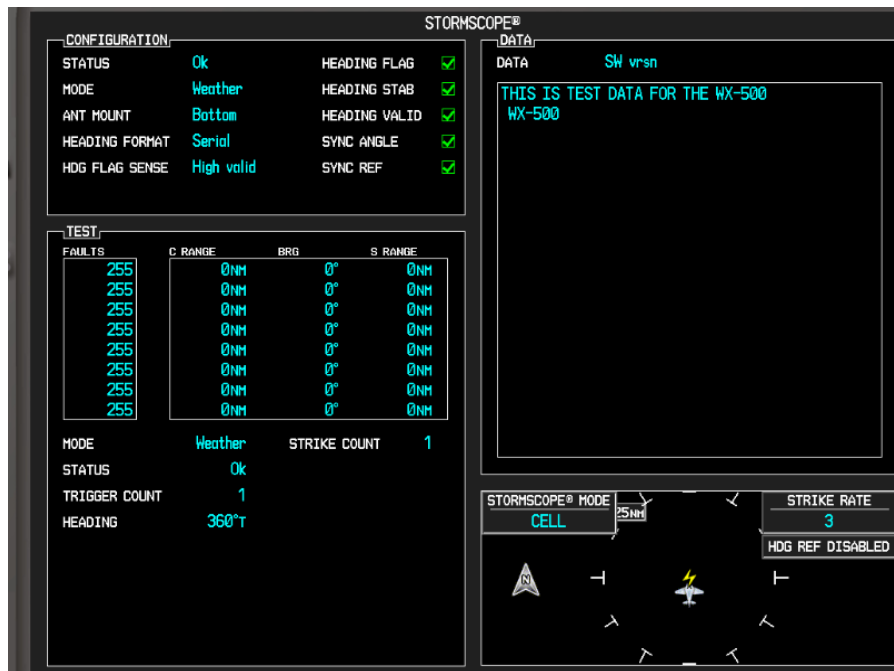
Figure 3-13, Stormscope Configuration Page

1. With PFD1 in configuration mode, use the PFD1 large FMS knob to select OTHER and the Stormscope configuration page.

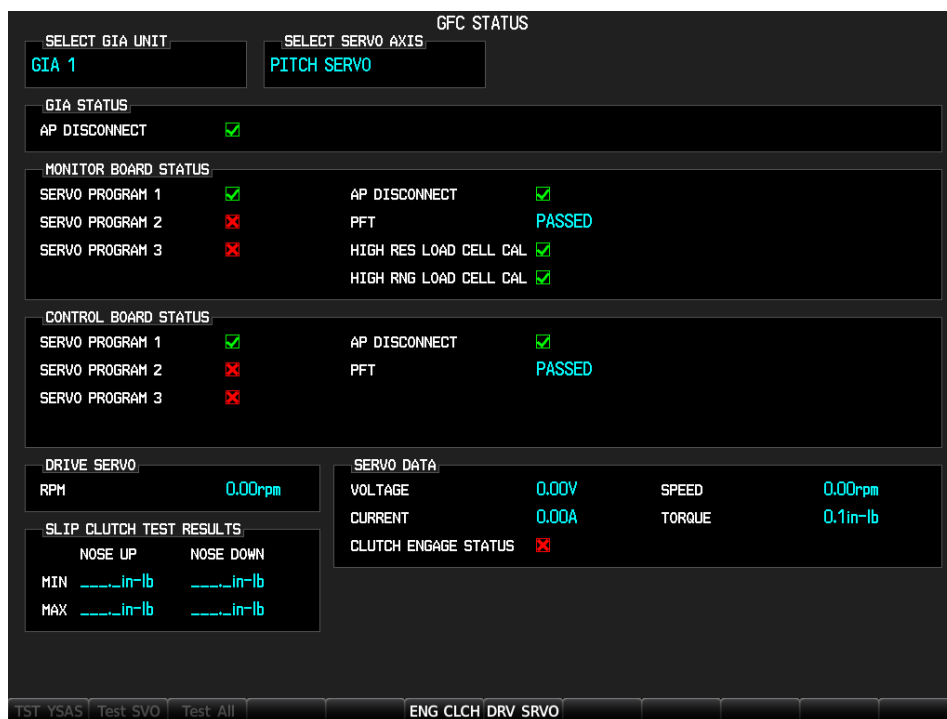
Figure 4-3, GFC Status Page

4. With the MFD in Normal Mode, press the red DISPLAY BACKUP button on the pilot's GMA audio panel to place the MFD in reversion mode.
5. With PFD1 in Configuration Mode, go to the GFC Page Group and select the GFC STATUS page using the FMS knobs.

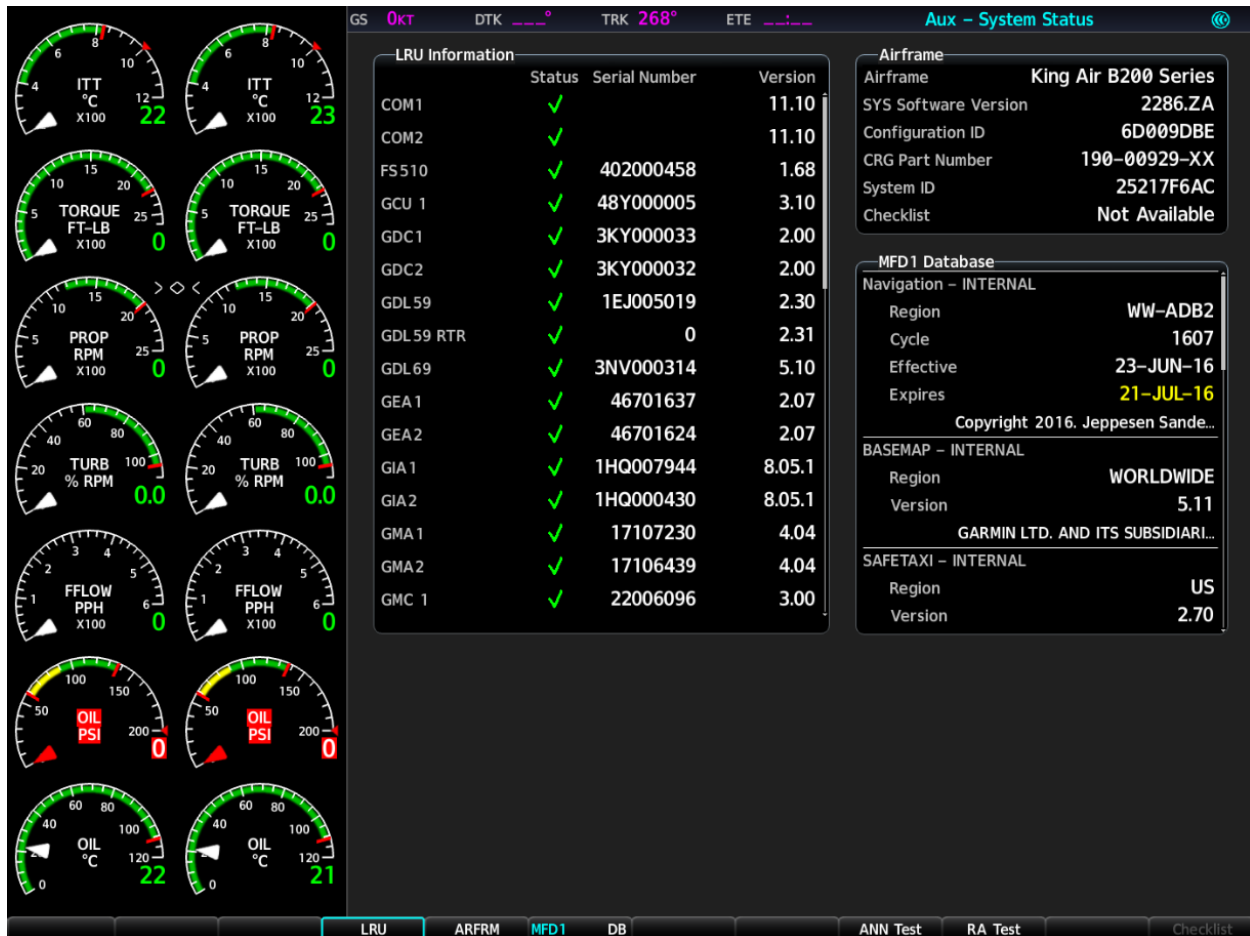
Figure 5-1, Aux – System Status Page

The **Aux – System Status** page displays the following information for each LRU and sub-function:

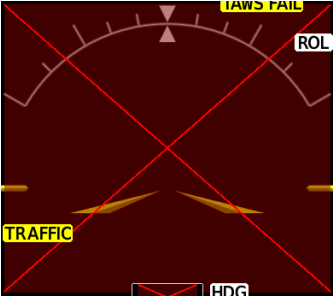
Invalid Data Field	Associated LRU(s)	Solution
<p style="text-align: center;">ATTITUDE FAIL</p>

<p style="text-align: center;">GSU 75B, GRS 77, or GRS 7800</p>	<ul style="list-style-type: none"> • Ensure that a cell phone or a device using cell phone technology is not turned on (even in a monitoring state) in the cabin. • Cycle GSU 75B, GRS 77, or GRS 7800 power to restart initialization. • Ensure GSU 75B, GRS 77, or GRS 7800 connector is secure and proper wire harness strain relief is provided. • Ensure the GSU 75B, GRS 77, or GRS 7800 is fastened down tightly in its mounting rack and that the mounting rack is not loose (CAUTION - do not loosen the mounting rack hardware to the airframe shelf or the aircraft will need to be re-leveled and the PITCH/ROLL OFFSET procedure performed). • Ensure GPS has acquired at least four satellites, has a 3D navigation solution, and a DOP of less than 5.0. This is particularly important for an ATTITUDE FAIL that appears during ground operation only. • Perform an Engine Run-Up Test to check if engine vibration is causing the GSU 75B, GRS 77, or GRS 7800 to go offline. • Load configuration files to the PFD, MFD, GIA1, and GIA2. • Calibrate the GSU 75B, GRS 77, or GRS 7800 (Pitch/Roll Offset and Magnetometer Calibration). • Replace GSU 75B, GRS 77, or GRS 7800. <ul style="list-style-type: none"> ✓ If problem persists replace GSU 75B, GRS 77, or GRS 7800 configuration module. ✓ Contact Garmin Aviation Product Support if condition continues after replacing the GSU 75B, GRS 77, or GRS 7800 and config module for additional assistance.

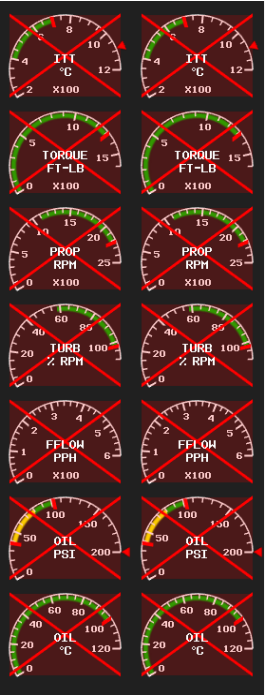
Invalid Data Field	Associated LRU(s)	Solution
<p>Engine/Airframe Sensors (All Invalid)</p>

<p>GEA 71 & GIA 63W</p>	<ul style="list-style-type: none"> • If software was loaded to a new GDU display, be sure that the user settings for the replaced display were cleared. Clear user settings by pressing the CLR key on the replaced display while applying power to it. Acknowledge the on-screen prompt by pressing the ENT key or the right-most softkey. • Check for GEA related Alert messages on the PFD. Correct any Alerts concerning software or configuration errors by reloading software or configuration as noted. • Verify GEA internal power supply, configuration, and calibration status in configuration mode. <ul style="list-style-type: none"> ✓ The internal power supply, configuration and calibration boxes should be green. If they are red, replace the GEA 71. • Verify internal, external, and reference voltages listed in the Main Analog and I/O A Analog boxes are not dashed out (does not include Aircraft Power 1 and 2). <ul style="list-style-type: none"> ✓ If any voltages are dashed out, replace the GEA. • Ensure the GEA is online (green checkmark on the Aux – System Status page). <ul style="list-style-type: none"> ✓ If GEA is not online verify unit is receiving power at the rack connector. ✓ Check the GIA/GEA interconnects for faults. ✓ Reload configuration files to both GIA's and the GEA. • If problem persists, replace the GEA 71.

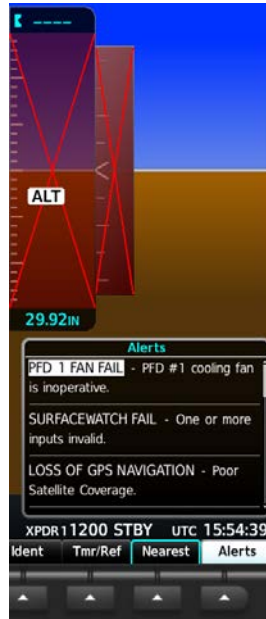
Figure 5-3, Alerts & Annunciations

The G1000 Alert System conveys alerts to the pilot using combinations of the following features:

When the G1000 Alerting System issues an alert, the Alerts softkey is used as a flashing annunciation to accompany the alert. During the alert, the Alerts softkey label flashes between white letters on black to black letters on a white. The flashing continues until the alert is acknowledged by a press of the Alerts softkey. The alerts softkey remains black letters on white until the condition causing the alert is corrected, or a new alert triggers the flashing.

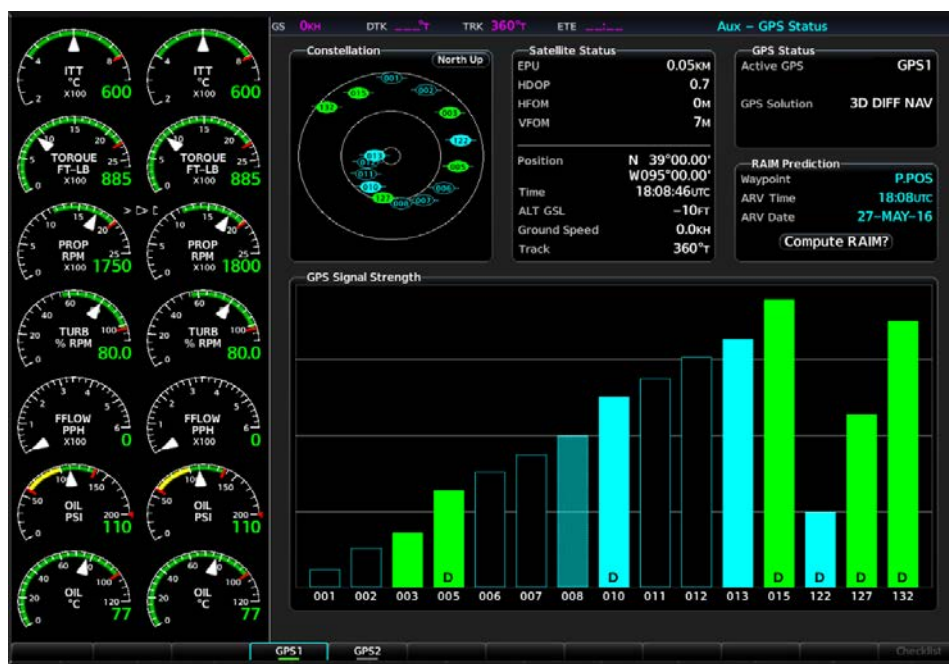
Figure 7-2, Aux – GPS Status Page (MFD)

The GIA 63W units should normally acquire a GPS navigation solution within 5 to 10 minutes of startup, provided the aircraft is outside (or indoors with a GPS repeater). Select the **Aux – GPS Status** page on the MFD. Two softkeys on the bottom of the display allow the user to toggle between GPS 1 and GPS 2. Verify that both receivers show 3D DIFF NAV on the MFD.

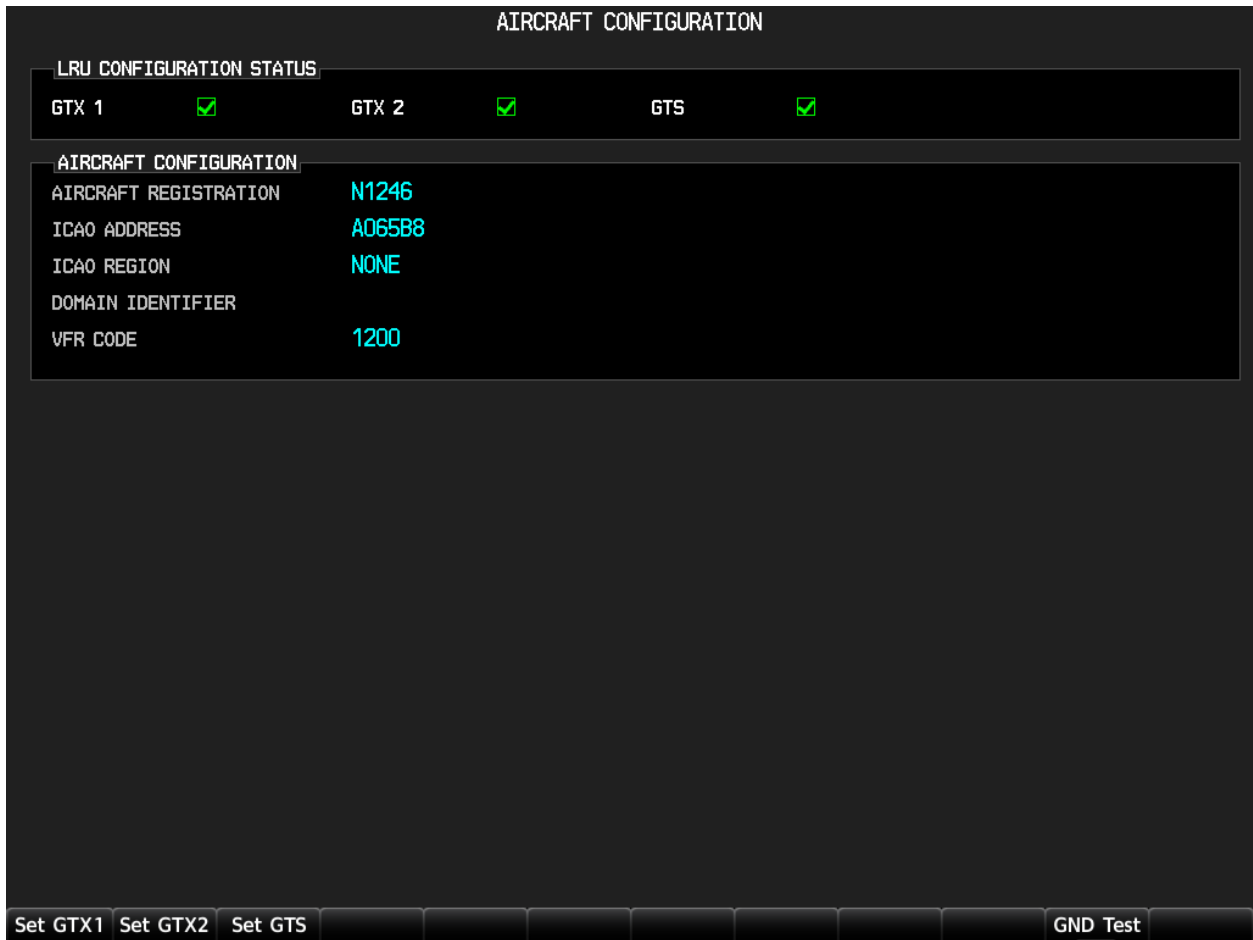
Figure 7-5, Aircraft Registration

1. If not applied, apply power to the G1000 system and put all displays into config mode.
2. On PFD1, select the AIRCRAFT CONFIGURATION page.
3. For GTX 33 unit replacement only, press the Set GTX # softkey for the unit replaced and acknowledge the PFD1 prompt by pressing the ENT key. For GTX 3000 units only, press the SET GTX softkey and acknowledge the PFD1 prompt by pressing the ENT key. GTX 335R and 345R units automatically save the registration number, no action is needed for these units.
4. After completing transponder configuration, deactivate the cursor.

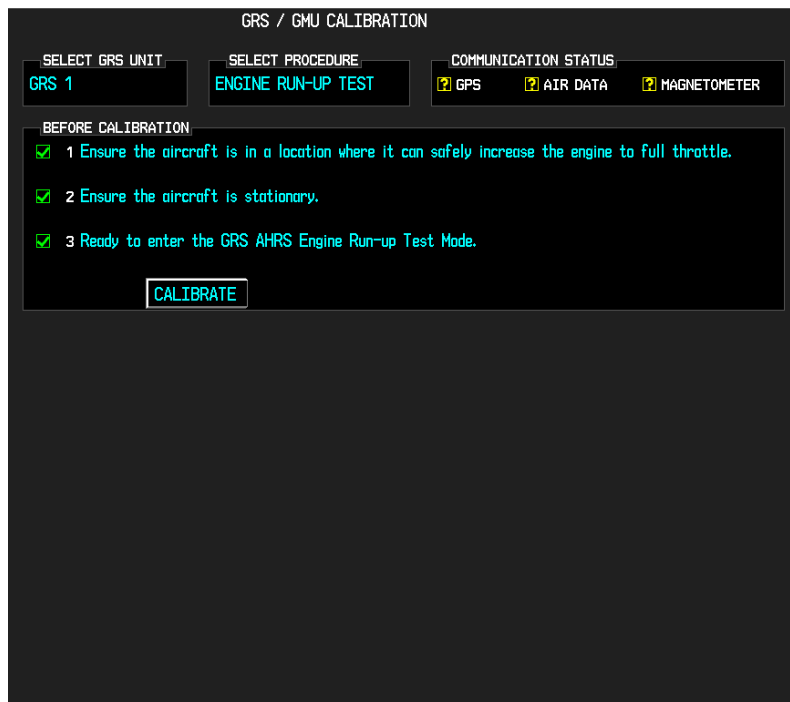
Figure 7-7, GRS/GMU Calibration, Engine Run-Up

Calibration Procedure D is performed in order to guarantee that the ADAHRS/AHRS mounting is sufficiently rigid and insensitive to vibration. This procedure must be performed for both GSU/GRS units installed in the aircraft. Calibration Procedures A1 and B (Sections 7.10.1 and 7.10.3 respectively) are not required prior to this procedure.

1. Restart PFD 1 in configuration mode.
2. Use the FMS small knob to highlight GRS 1 for calibration and press the ENT key. The SELECT PROCEDURE field is not blinking.
3. Initiate the AHRS engine run-up vibration test procedure by performing the following steps:
 - a) Select the ENGINE RUN-UP TEST procedure and press the ENT key.
 - b) Follow the checklist items displayed on the PFD, and press the ENT key as each one is completed or confirmed. When the CALIBRATE field is blinking, press the ENT key to begin the procedure.
4. The PFD display instructs the operator to gradually increase power from idle to full throttle and back to idle over a period of 2-4 minutes.
5. When the operator has completed the engine run-up and the engine is back to an idle setting, press the ENT key to indicate that the process is complete. When this is done, the TEST COMPLETE field stops blinking.

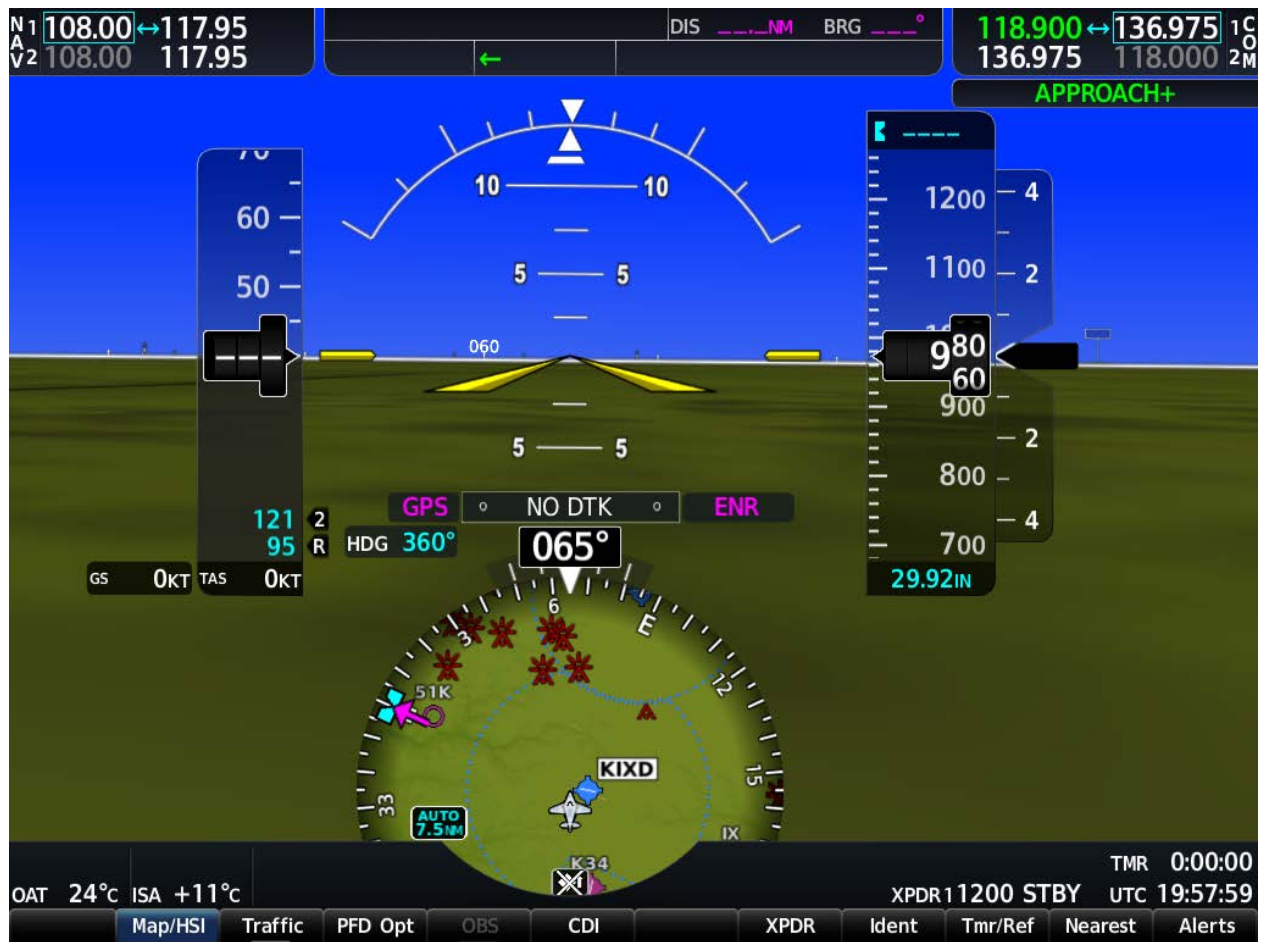
Figure 7-8, Normal Mode AHRS Check

Start the displays in normal mode. The ADAHRS/AHRS attitude and heading information displayed should become valid within 1 minute of power-up as shown in Figure 7-8 if at least one GPS receiver has a valid position. If GPS is unavailable, the ADAHRS/AHRS initialization may take up to 2 minutes.

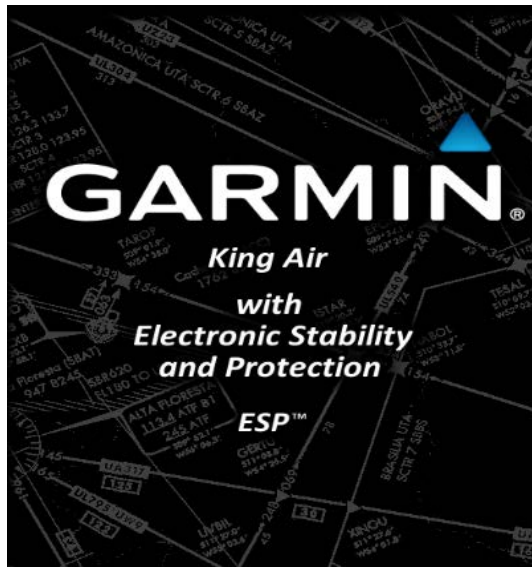
1. Apply power to the aircraft and avionics systems by placing the aircraft AVIONICS MASTER PWR and BATT switches to ON. Ensure G1000 system and components are powered and operating normally.
2. Verify the DISPLAY BACKUP button on the audio panel is pushed in so that the GDUs will not operate in reversionary mode.
3. Verify no AHRS, ADC, Autopilot, PFD, AFCS Mode Controller, GCU alert messages or monitor flags (amber **HDG**, etc.) are present on PFD1 or PFD2.
4. On initial power up verify that the MFD splash screen includes a graphic similar to the following:

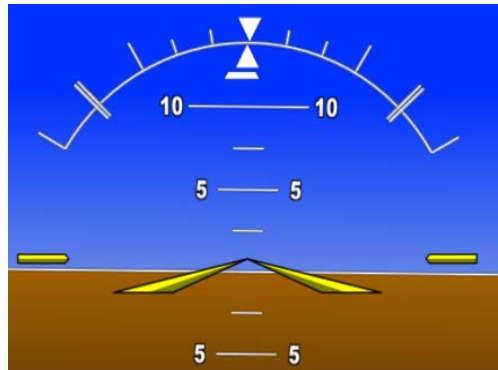
10. Cover both GPS1 and GPS2 antennas.
11. Verify on PFD 1 and PFD 2 the ESP Roll Indices are displayed at 45° on the roll indicator on the Attitude Display.

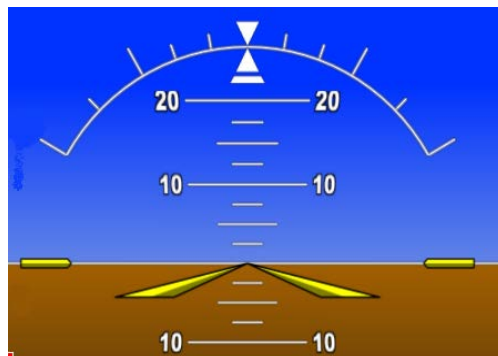
15. Verify on PFD 1 and PFD 2 the ESP Roll Indices are not displayed at 45° on the roll indicator on the Attitude Display.

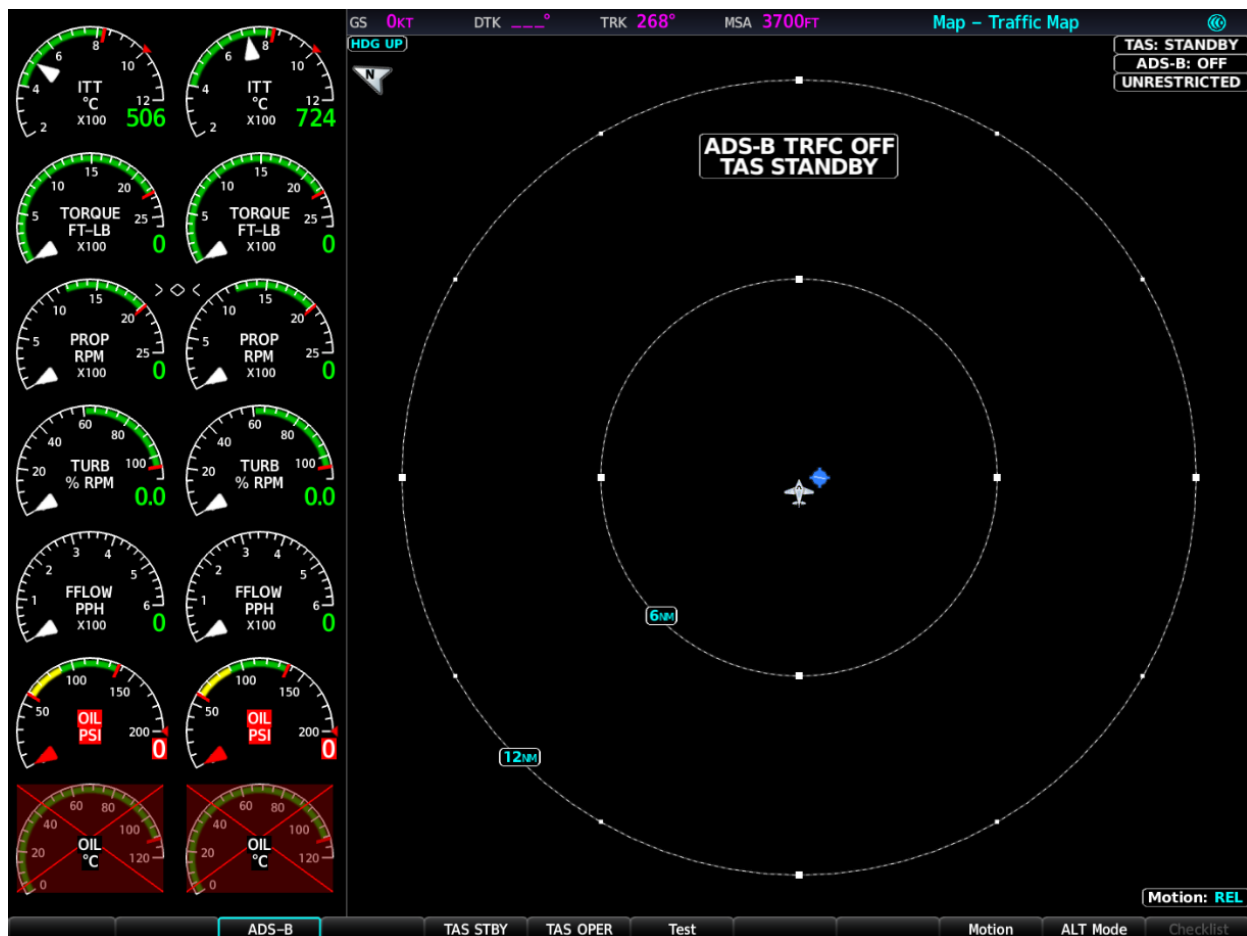
Figure 8-8, Traffic Map

1. On the **Map – Traffic Map** page of the MFD, perform the following:
 - a. Press the **TAS OPER** softkey (for TAS/TCAS I) or press **TA Only** softkey (for TCAS II). A self-test of the antenna circuit is initialized. If the MFD displays FAILURE at the upper left corner of the traffic display area, it will be necessary to recheck the coaxial connections. If MFD displays OPERATE (for TAS/TCAS I) or TA ONLY (for TCAS II) without indicating a fault, proceed to the next step of antenna verification.

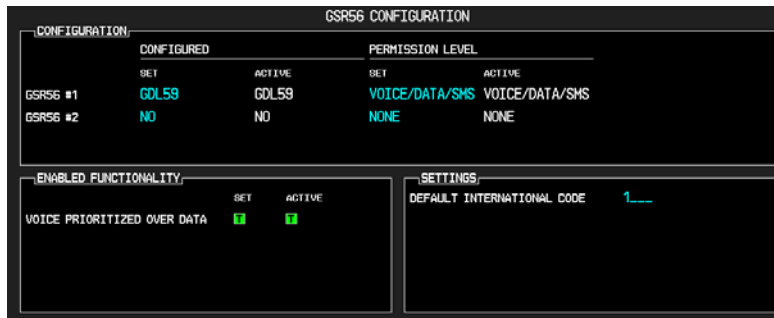
Figure 8-9, GSR56 Configuration Page

1. Power up the PFD1 in configuration mode.
2. On the PFD1, select GDL page group using the large FMS knob.
3. Using the small FMS knob select the GSR56 Configuration page. Verify the page can be displayed and information is available.

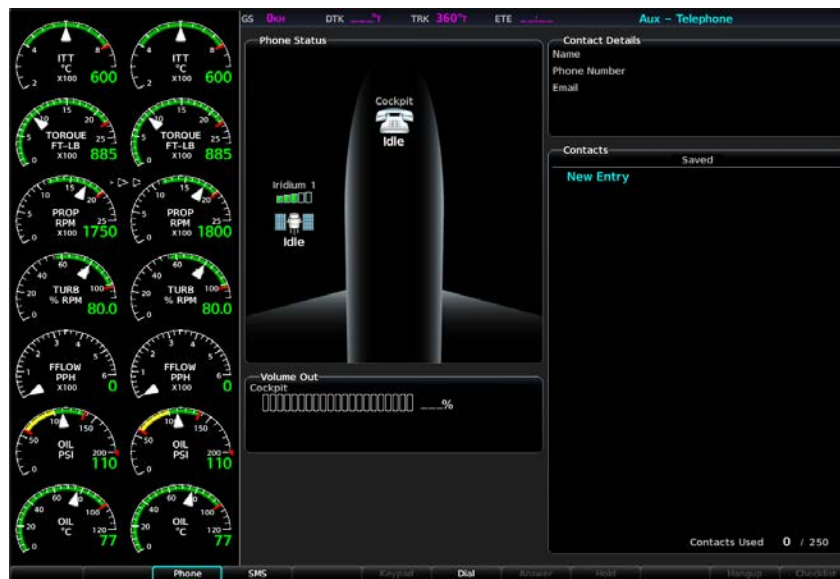
Figure 8-10, Aux-Telephone page

4. Restart the G1000 System in Normal Mode.
5. Using the large FMS knob, select the Aux page group on the MFD. Using the small FMS knob, select the **Aux-Telephone** page.
6. Ensure the system is showing Iridium signal strength (best if aircraft is outside).
7. Press **TEL** button on the pilot's GMA.
8. Press the **Dial** softkey on the MFD.
9. Enter the test phone number in the ENTER PHONE NUMBER field using the GCU keypad.
10. Press the **ENT** key on the GCU keypad to accept the phone number.
11. Press the **ENT** key on the GCU keypad to initiate the dialing sequence.
12. When call is complete, press the **Hangup** softkey on the **Aux-Telephone** page on the MFD to end the call.

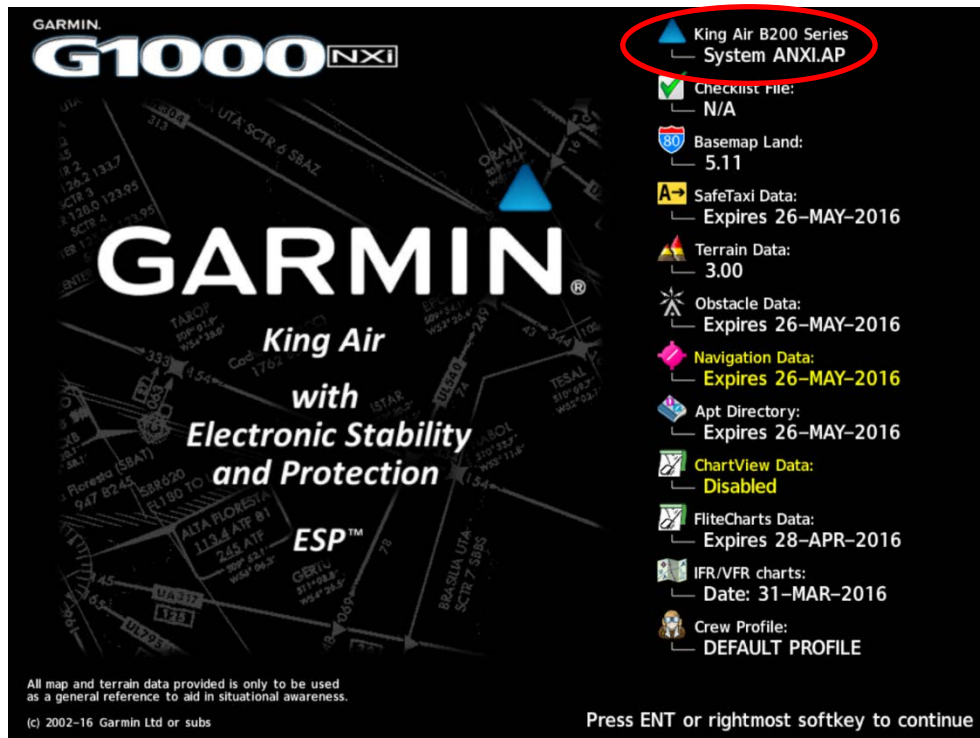
Figure 9-1, MFD Power Up Page

1. Apply aircraft power. On the MFD power-up screen in the upper right corner, find the 'King Air B300 Series System XXXX.XX' number. This number is the G1000 System Software Loader Image version number that was used to install the software to the system.

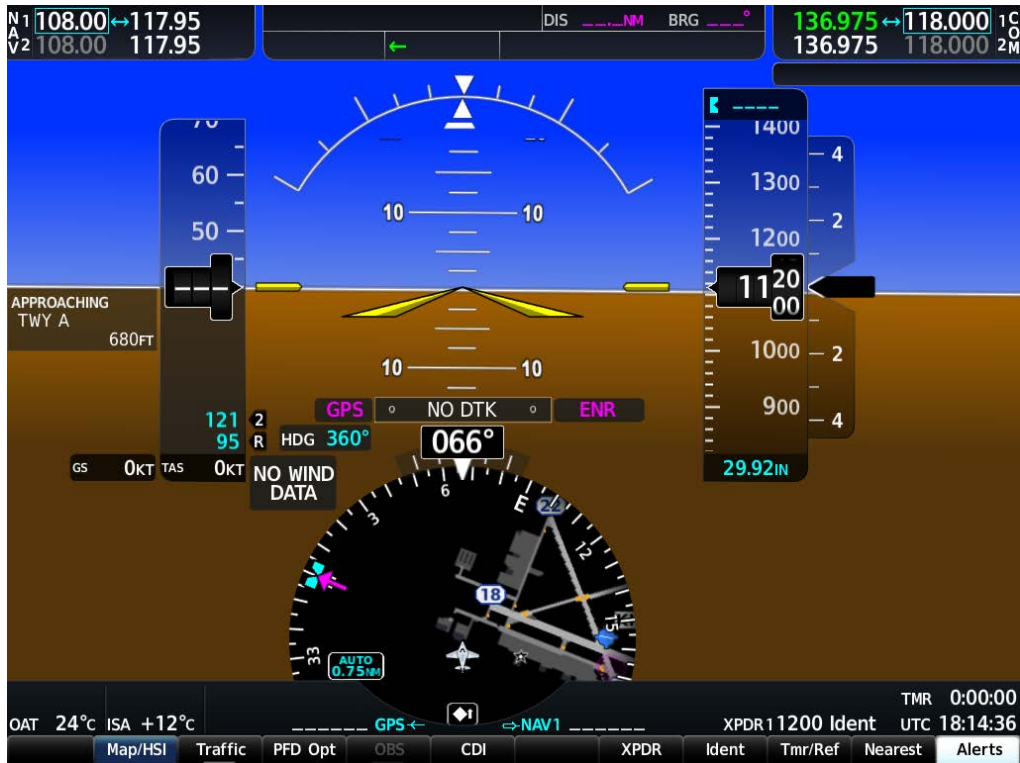
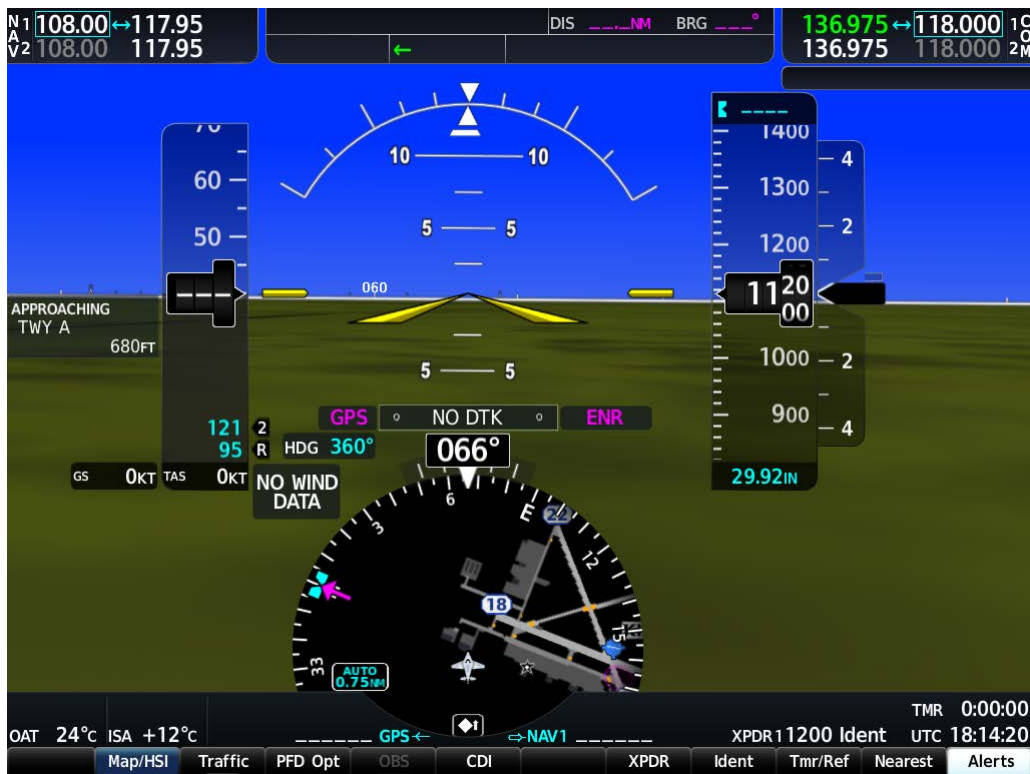
Figure 9-3, PFD Normal Operation

4. Allow the displays to initialize for approximately one minute. During normal operation, this causes the airspeed, altitude, vertical speed, and OAT fields to be invalid during the first ~40-60 seconds of PFD power-up. After two minutes, verify no Red-X's are present on both PFDs and the MFD. Examples of potential Red-Xs are shown in Figure 9-2. If any Red-X's are present, stop and troubleshoot per Section 5. Examples of PFDs with no Red-X failure indications are shown in Figure 9-3.

(Without SVS enabled)

(With SVS enabled)
