G1000 **NXi**

System Maintenance Manual

King Air 300 Series

**Includes Instructions for Continued Airworthiness
for STC SA01535WI-D**

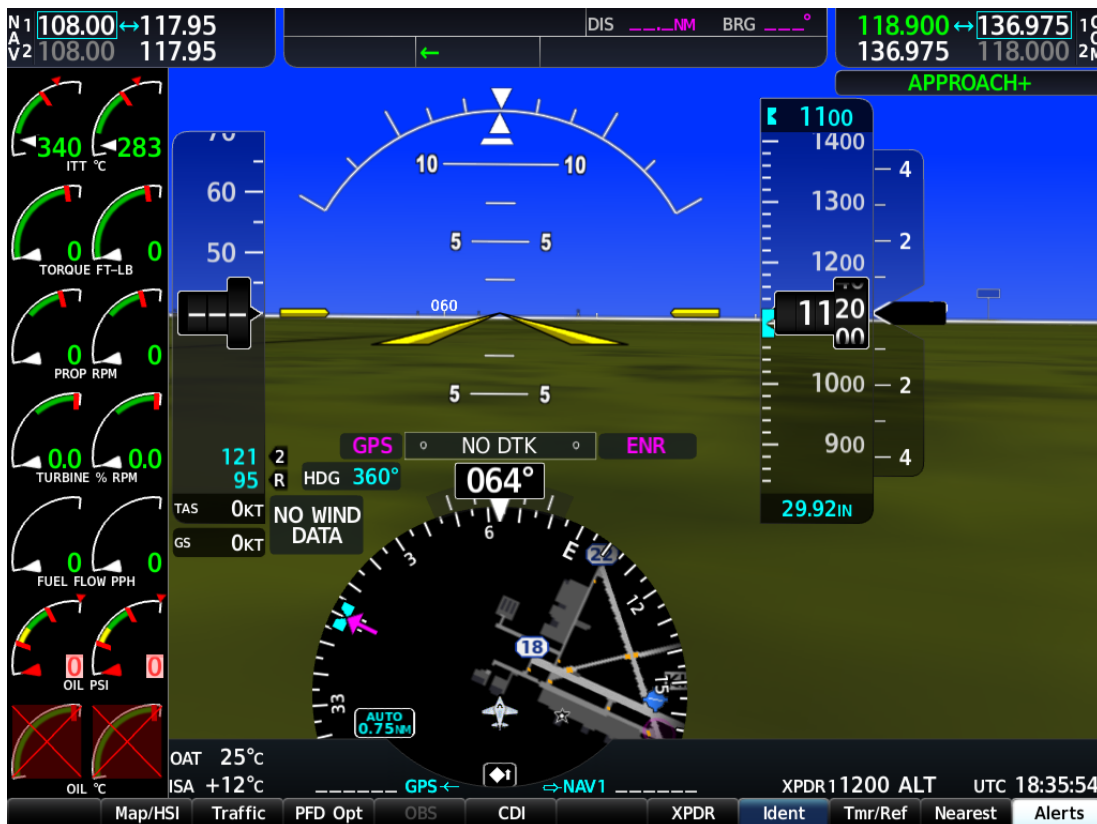
Figure 9-4, GDU Reversionary Mode

1. Push the red **DISPLAY BACKUP** button on the pilot-side GMA 1347D. Verify that the pilot-side PFD and MFD displays enter reversion mode (See Figure 9-4). MFD should have valid altitude, airspeed, vertical speed, COM 1, COM 2, NAV 1, NAV 2 and engine instruments.

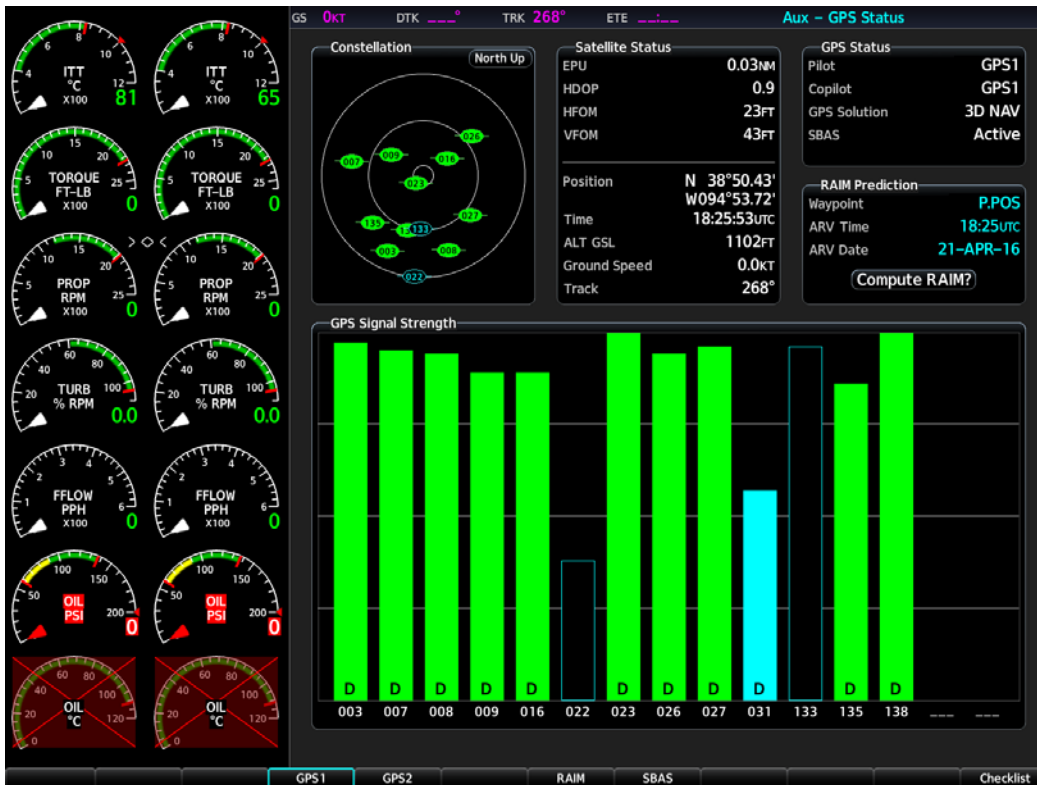
Figure 9-5, AUX-GPS Status Page

Select the AUX - GPS Status page on the MFD. After the G1000 system has been on for a minimum of two minutes, toggle between GPS 1 and GPS 2 using the two softkeys on the bottom of the display. Verify that both receivers show a 3D GPS Solution in the GPS Status field.
